### MUNICIPAL SEPARATE STORM SEWER SYSTEM (MS4) PERMIT PROGRAM

### **2017 ANNUAL REPORT**

DEPARTMENT OF PUBLIC WORKS DECEMBER 21, 2017

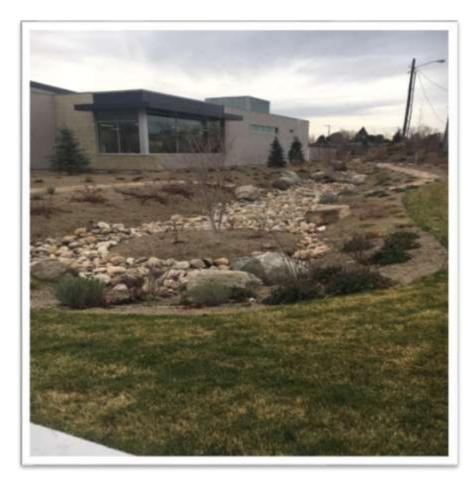
Figure 2: Bown Library Bio-swale Stormwater Facility

The project involved the construction of a new 16,000 square foot branch library on a 3-acre undeveloped parcel. Stormwater from the building roof, parking and other hardscape areas will be retained on site and infiltrated. Groundwater is relatively shallow in some parts of the site and influenced the drainage design.

The selected approach involves a mix of infiltration bio-swales and permeable pavers. Bio-swales will utilize 12" of bioretention soil which was selected to enhance pollutant removal and plant growth. Sand windows are also utilized at low points to ensure swales will drain. Permeable pavers were utilized where there was not sufficient depth to groundwater. Beyond the normal paver section, a 12" layer of filter sand will provide additional infiltration.

Use of green stormwater infrastructure avoids the release of 12,200 cubic feet of stormwater in a 1"/1-hour storm event. The site grading was designed to ensure that the design storm discharge is retained onsite or in the instance that the stormwater facilities do not perform properly, the stormwater may pond but will not discharge. To date, the facilities have functioned as designed. Given these site design considerations and the anticipated performance of the facilities, a quantitative evaluation has not been completed.

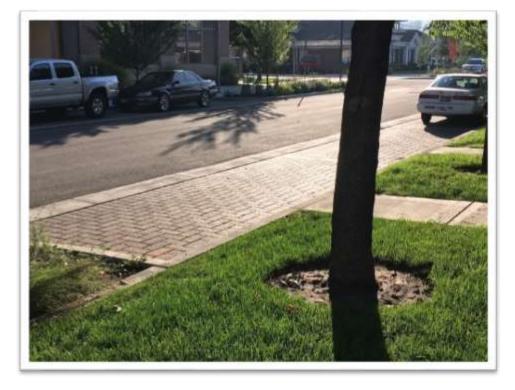
### Figure 3: GSI in the Central Addition LIV District

Another significant GSI project was completed this year in coordination with the implementation of the City's Central Addition LIV District (eco-district). Broad Street, in the Central Addition, was reconstructed to incorporate a number of sustainability elements including green stormwater infrastructure, a new streetscape design incorporating enhanced urban street trees and mobility improvements for pedestrians and bicycles. GSI facilities include permeable pavers and suspended pavement systems (which support tree growth and infiltrate stormwater) that are installed within parking lanes in the roadway and under the sidewalks. These facilities manage stormwater from the adjacent roadways, which previously discharged directly to the storm drain system and where possible drainage from adjacent properties. The project also served as an opportunity to pilot an offsite mitigation compliance approach for a private development project in the Central Addition. The project was made successful through a cooperative effort between the City,

ACHD, Capitol City Development Corporation (CCDC-Boise's Urban Renewal Agency) and the property owners and residents of the Central Addition. It serves as a model for future innovative approaches to managing stormwater in Downtown Boise.

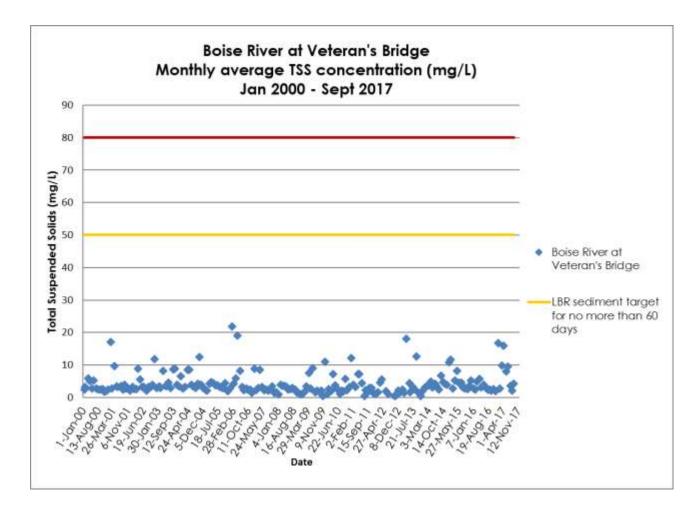
Figure 1: Boise River at Veteran's Bridge Monthly TSS data Jan 2000-Septmber 2017

All observed TSS concentrations in the lower portion of the MS4 area are significantly below the Lower Boise TSS TMDL targets during the period 2000-2017 (Figures 1 and 2). The observed WY17 TSS concentrations and loads were higher than in previous years. Although the Boise River at Glenwood and Veteran's Bridges experienced increased sediment concentrations, TMDL targets were not exceeded. The observed TSS at similar flow years could not be calculated due to the extreme river conditions this year. The increased TSS level in 2017 appears to be winter rain and flood related and is not related to MS4 practices.

Annual average concentrations have been calculated for each location to assess MS4 performance and pollutant trend. Annual average TSS concentrations in WY17 are atypical due to winter rain and flood conditions (Figure 3).

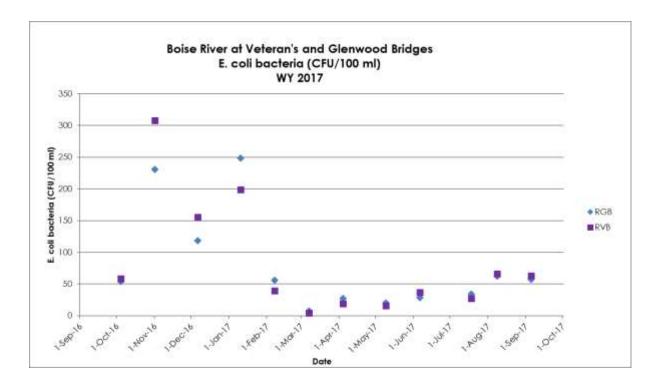
### Figure 4: Boise River at Veteran's and Glenwood E. coli Bacteria: WY2017

Monthly sampling shows similar *E. coli* levels, which suggests the Boise/Garden City MS4 is not causing or contributing to exceedance of the *E. coli* recreational water quality standard (126 CFU/100 ml 30 day geomean) or the 2012 EPA recommended water quality standard (126 CFU/100 ml 30 day geomean and 410 CFU/100 ml STV) in the MS4 reach.

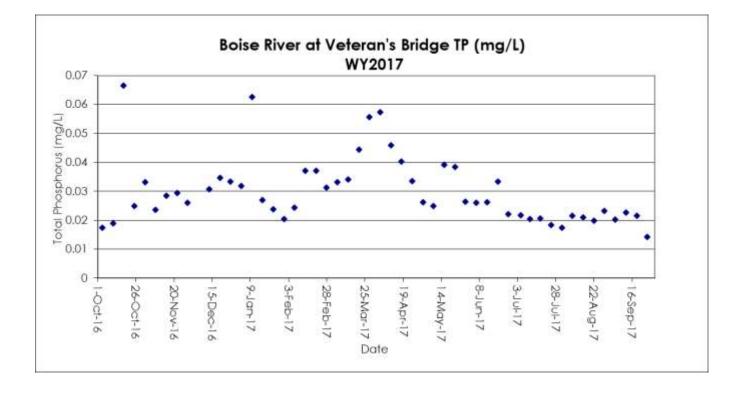
### Figure 6: Boise River Weekly TP at Veteran's Bridge: 2017

WY2017 weekly TP data for Veteran's are shown in Figure 6, 2000-2017 weekly TP data are in Figure 7 and annual average TP data are shown in Figure 8. Total phosphorus concentrations were elevated in the Boise River at Veteran's Bridge October 2014-May 2015 due to fires and summer thunderstorm runoff for 2014 and primarily rain at low elevation and snow and rain on snow at higher elevation during the winter and spring of 2014/15. The observed values are 3-4 times the observed TP concentration from the historical record and appear to be related to the ongoing impacts of the 2014 fires on increased TSS and TP due to increased runoff in the fire impacted areas of the upper watershed. As described, flood conditions contributed to increased TSS and TP concentrations and loads in 2017. Both of the trendline figures (Figures 9 and 10) show that 2014, 2015 and 2017 appear to be outliers, with TP annual average concentrations and weekly TP data at 3-5 time the observed long term TP concentration.

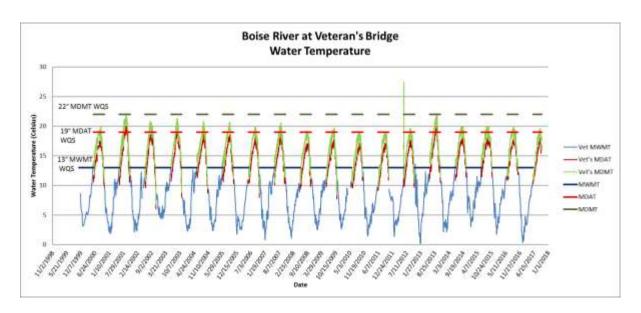
Figure 12: Veteran's Temperature WY2017

The most significant exceedances of the cold water aquatic life water quality standard(s) occur, (e.g. 2001, 2013) in the August and September timeframes when little, if any, discharge from the MS4 is occurring. Temperature and precipitation data suggest that discharges from the MS4 are not the cause of observed water quality exceedances and do not cause or contribute to exceedances of temperature water quality standards at levels that warrant additional controls on Boise City MS4 structures or practices.

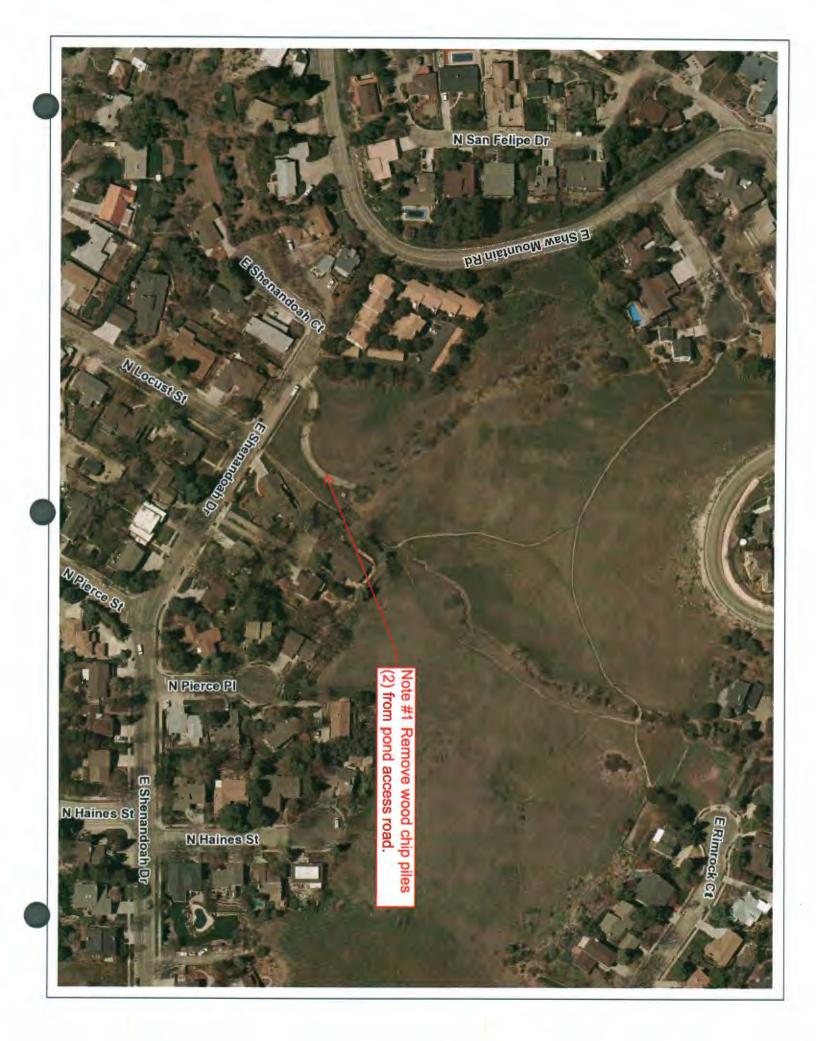
SITE LOCATION: Cottonwood Ponds

1. Remove wood chip piles (2) from pond access road.

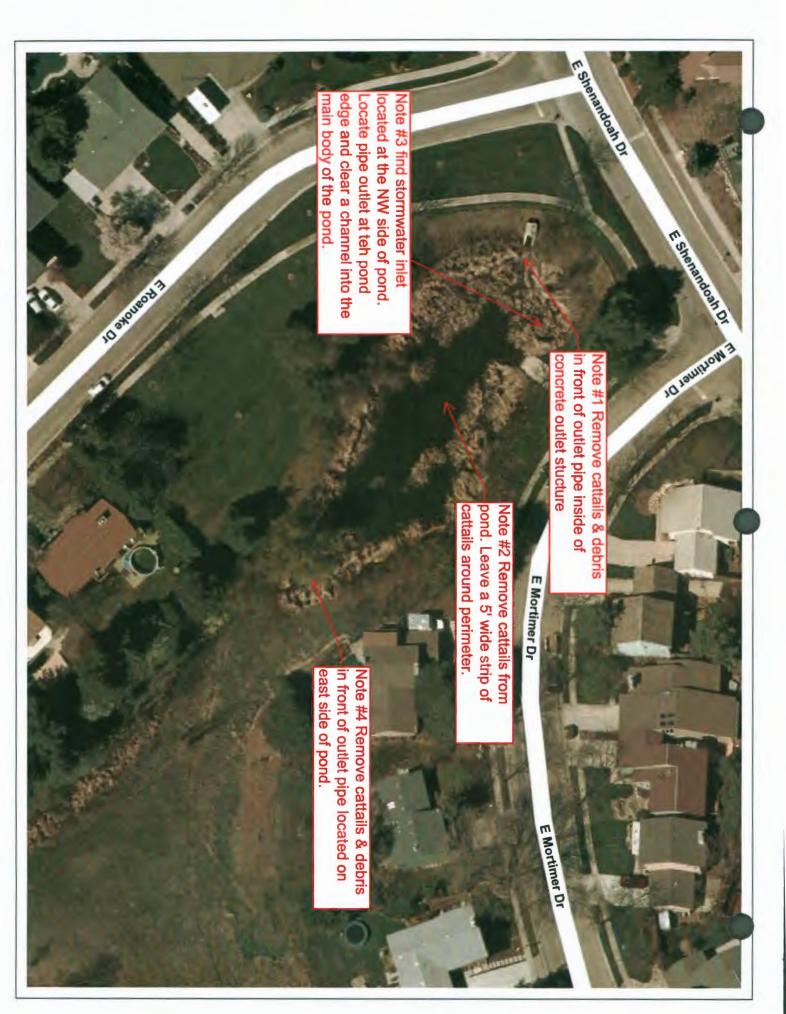
- 1. Remove debris and cattails in front of outlet structure.
- 2. Cattails have encroached all the way to the concrete pond bottom. Remove cattails. Leave a perimeter strip of cattails approximately five to ten feet wide along all pond edges.
- 3. There is a stormwater inlet located at the northwest side of the pond. Locate the pipe outlet at the pond edge and clear a channel into the main body of the pond.
- 4. Remove cattails and debris below the inlet pipe located at the east side of the pond.
