**MUNICIPAL SEPARATE STORM SEWER SYSTEM (MS4) PERMIT  
PROGRAM**

**2018 ANNUAL REPORT**

**DEPARTMENT OF PUBLIC WORKS  
DECEMBER 21, 2018**

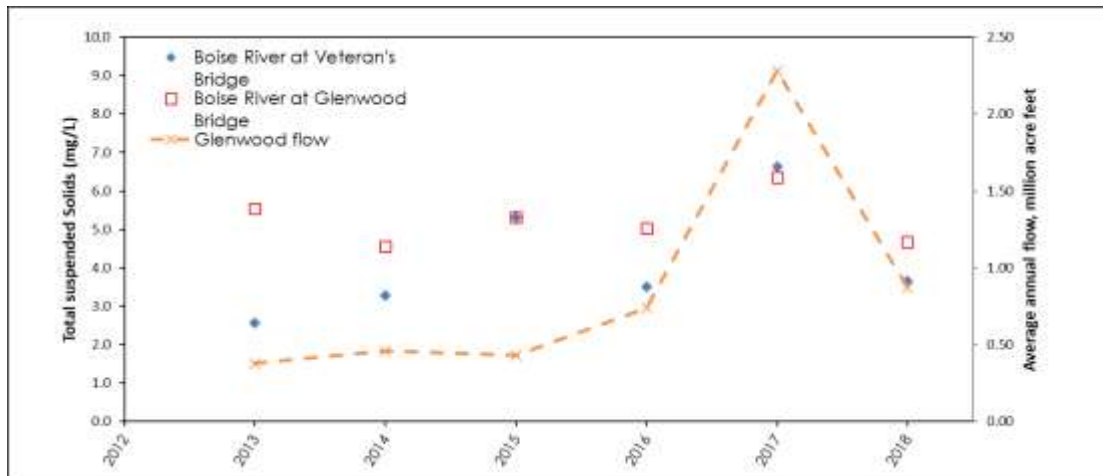
Average annual TSS concentrations at Veteran's and Glenwood were between 2.5 and 6.5 mg/L between WY 2013 and 2018 (Figure 3). Annual concentrations increased slightly with increasing flow in 2017. This increase in 2017 could be related to increased spring runoff or storm events.

**Figure 2: Annual average total suspended solid (TSS) concentrations (mg/L) for the Boise River at Veteran's and Glenwood Bridges; and flow (million-acre feet) from USGS gage (132060000) for water years 2013-2018.**

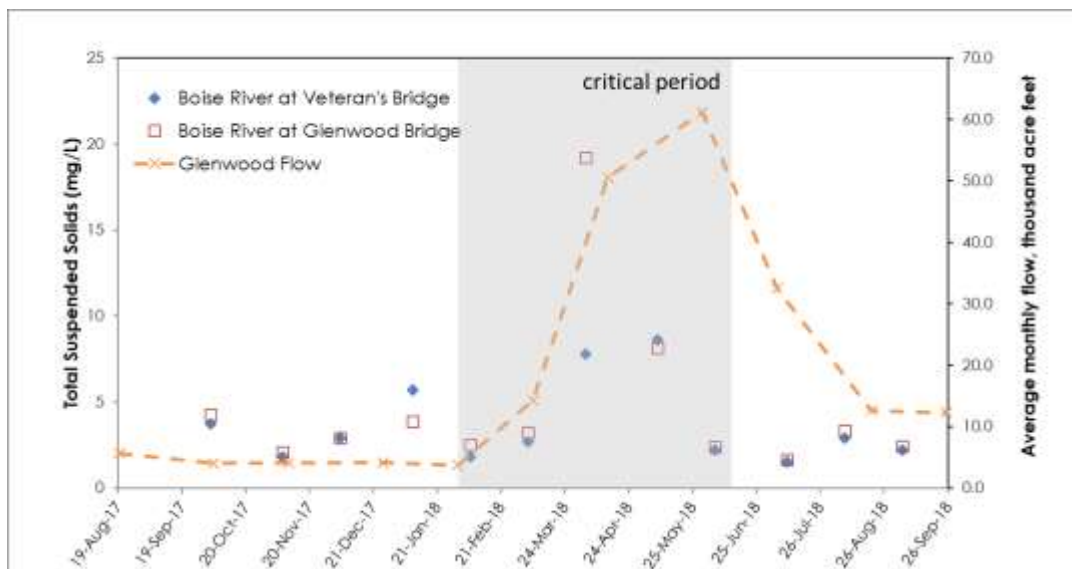
Monthly average TSS concentrations in WY 2018 remained below 10 mg/L except at Glenwood in April 2018. The increase was during the critical period and may be due to the sudden increase in flow during spring runoff (Figure 4). Durational TMDL targets could not be evaluated with the data collected but WY 2018 TSS monthly trends fall well below the 50 (60-day) and 80 (14-day) mg/L values.

**Figure 3: Monthly average total suspended solid (TSS) concentrations (mg/L) for the Boise River at Veteran's and Glenwood Bridges; and flow (thousand-acre feet) from USGS gage (132060000) for water years 2018.**

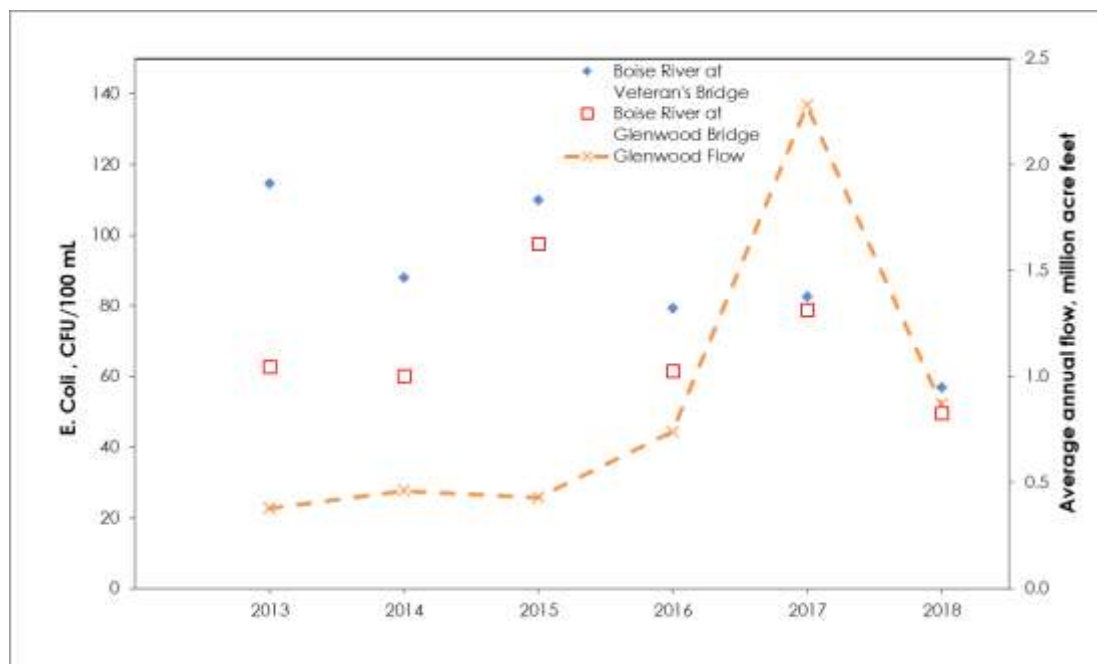
Annual average *E. Coli* concentrations were between 50 and 115 CFU/100 mL for the Veteran's and Glenwood sites. The upstream site at Veteran's had consistently higher *E. Coli* concentrations until the last two water years (Figure 5). The increase in average annual flow did not appear to affect *E. Coli* concentrations at the City of Boise monitoring sites.

**Figure 4. Annual average Escherichia coli (*E. Coli*) Bacteria concentrations (mg/L) for the Boise River at Veteran's and Glenwood Bridges; and flow (million-acre feet) from USGS gage (132060000) for water years 2013 -2018.**

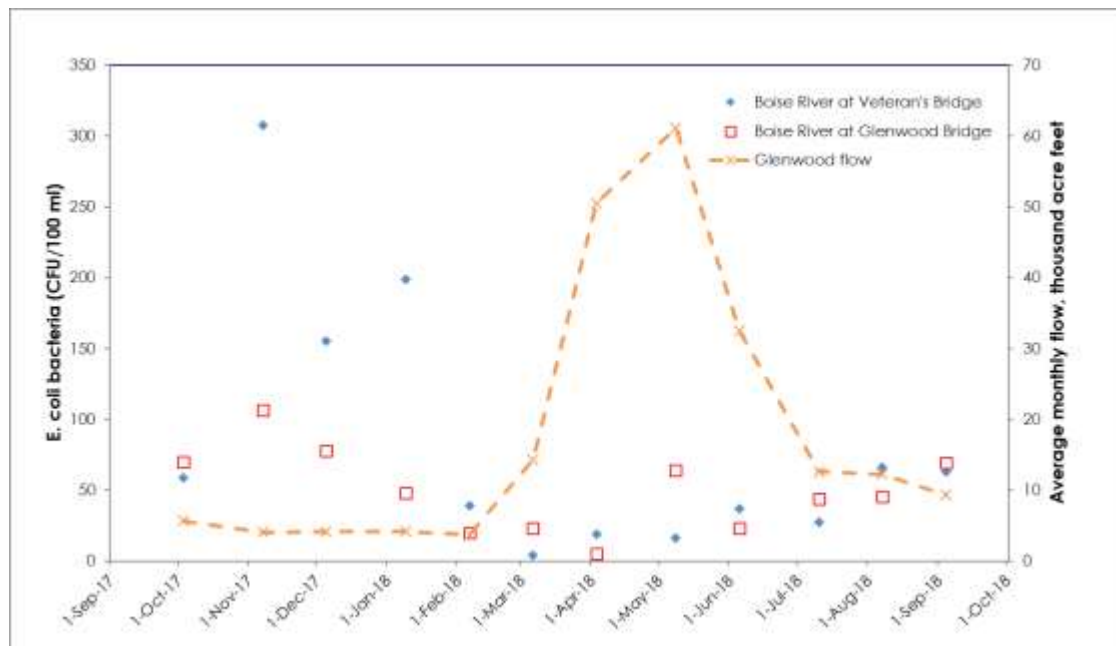
*E. Coli* concentration for WY 2018 were between 5 and 308 CFU/100 mL and the highest concentrations occurred in December, January and February at Veteran's when lower monthly average flows were less than 5000 acre feet (monthly average measured at Glenwood; Figure 6). *E. Coli* concentrations during higher spring flow and through the summer months remained below 70 CFU/100 mL. Water year 2018 concentrations were below the recommended single sample value of 406 CFU/100mL recommended to protect health.

**Figure 5. Monthly average *Escherichia coli* (*E. Coli*) concentrations (colony forming units/100 mL or CFU) for the Boise River at Veteran's and Glenwood Bridges; and flow (thousand-acre feet) from USGS gage (132060000) for water year 2018.**

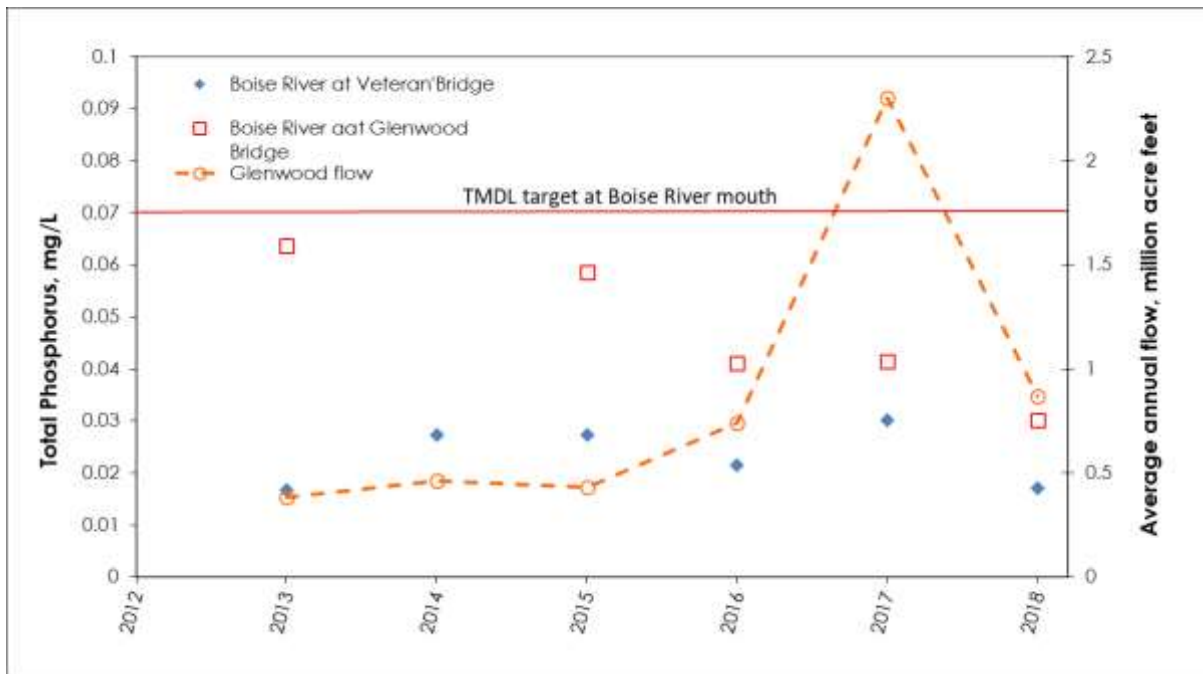
Annual average concentrations in total phosphorus between water years 2013 and 2018 were between 0.02 and 0.08 mg/L at Veterans and Glenwood (Figure 7) with higher concentrations at Glenwood. The Glenwood sampling

site is downstream from the Lander WRF outfall and in the center of the Boise metropolitan area. Reduction in the annual average TP in 2016 may be due in part to the Lander WRF implementation of enhanced biological nutrient removal (EBNR) during that time. Although annual average TP concentrations at Glenwood in WY 2018 (0.03 mg/L) are still higher than Veteran's, they are less than half the 2014 concentration (0.08 mg/L and below the 0.07 mg/L TMDL target).

**Figure 6. Annual average total phosphorus concentrations (mg/L) for the Boise River at Veteran's and Glenwood Bridges; and flow (million-acre feet) from USGS gage (132060000) for water years 2013 -2018.**

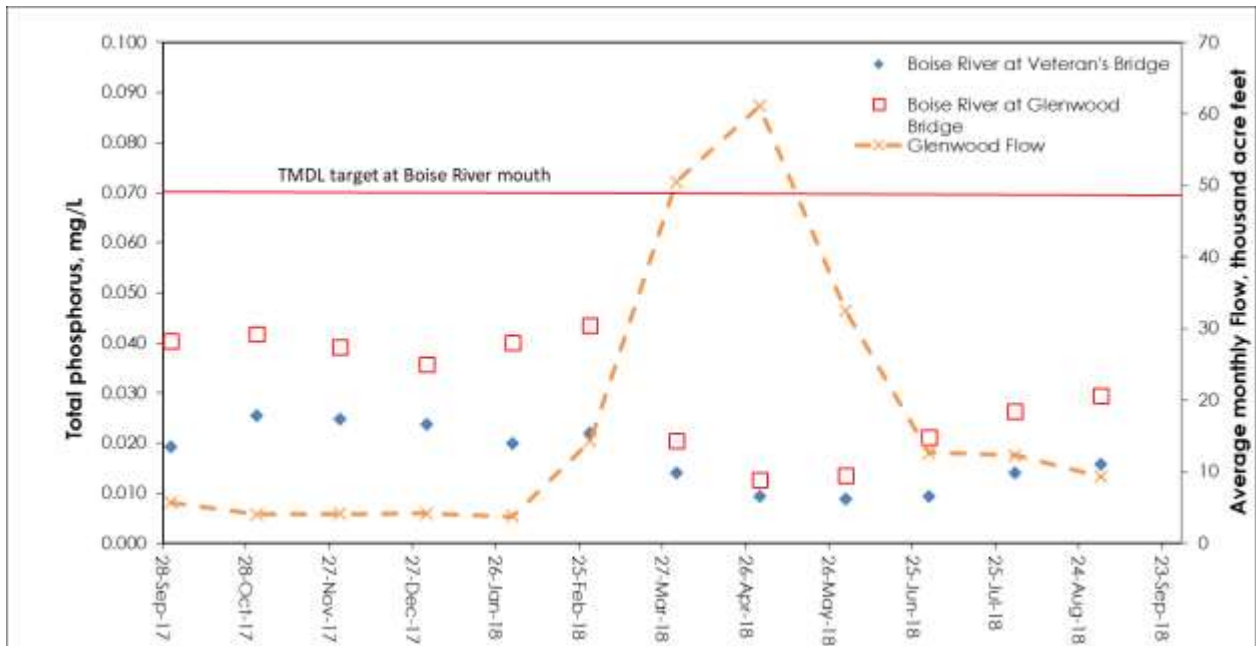
Monthly average TP concentrations for WY 2018 remained below the TMDL target (Figure 8). Higher monthly average TP at Glenwood during the winter months may be a factor of lower flow. During the target period (May – September) TP was below 0.03 mg/L, less than half the TMDL target. Increase in flow in April – June 2018 appeared to have a slight impact on TP concentrations and concentrations at Glenwood were reduced by more than half.

**Figure 7. Monthly average total phosphorus concentrations (mg/L) for the Boise River at Veteran's and Glenwood Bridges; and flow (thousand-acre feet) from USGS gage (13206000) for water year 2018.**

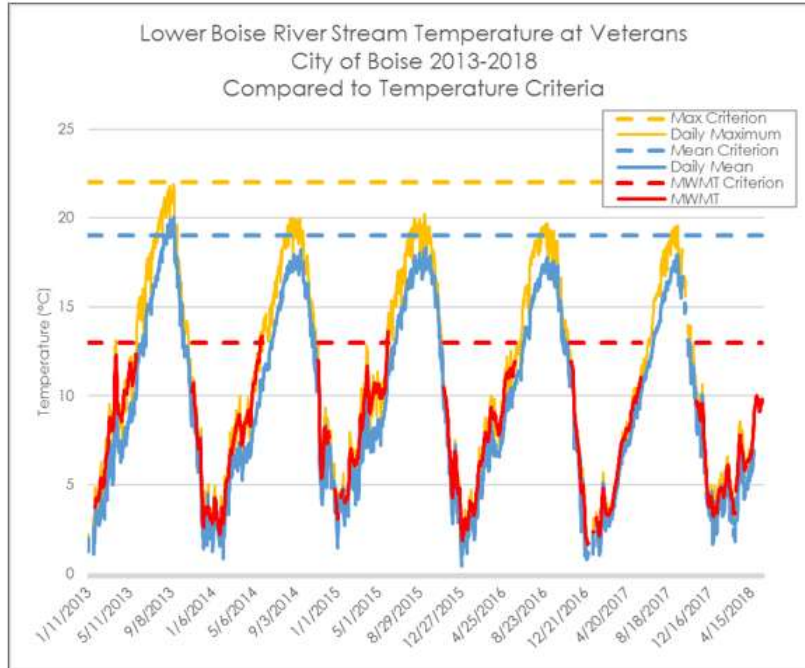
The Lower Boise River is listed as temperature impaired from Veteran's to the mouth. The City has collected continuous 15-minute water temperature data from Veteran's and Glenwood to meet discharge permit requirements (USEPA, 2012a, 2012b) and Idaho State cold-water and salmonid spawning criteria (IDAPA, 2018). The cold-water aquatic life standard of 19°C maximum daily average temperature (MDAT) and 22°C maximum daily maximum temperature (MDMT) apply year-round. The salmonid spawning standard of 13°C maximum weekly maximum temperature (MWMT) applies from November to May. Continuous temperature recorded at Veterans between WY 2013 and 2018 exceeded criteria less than 5% of the time in 2013, 2014 and 2015 (Figure 11). There were similar results at Glenwood with criteria exceedance up to 8% of the time between 2013 and 2015 and no exceedances in the last three years. Higher water temperatures occur during the summer months. There have been no exceedances criteria at either Veteran's or Glenwood in the last three years.

**Figure 8: Stream temperature at Veteran's Bridge and Glenwood Bridges and applicable criteria and temperature exceedances for water years 2013 – 2018.**

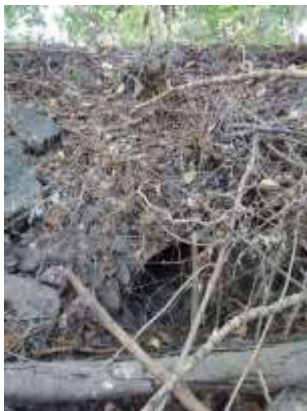
**Outfall Inspection Summary****Outfall ID:** 3n2e10\_041**Date:** 09/07/2018**Comments:** Couldn't find actual OF but DI in parking lot (which likely feeds OF) is dry.

| <b>Structural Condition</b> | Poor, Filled with rock | | | | |

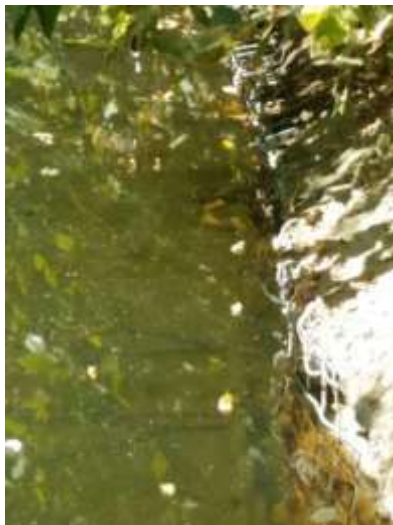
**Outfall Inspection Summary****Outfall ID:** 3n2e10\_044**Date:** 09/07/2018**Comments:** OF is underwater. No flow.

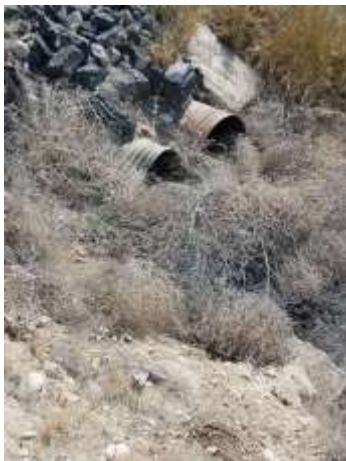
**Outfall Inspection Summary****Outfall ID:** 3n2e32\_001 – BOISE CITY**Date:** 09/07/2018**Comments:** Dry.

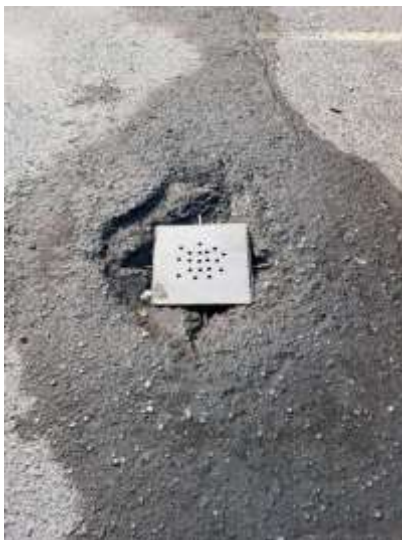
**Outfall Inspection Summary****Outfall ID:** 3n2e10\_015**Date:** 09/11/2018**Comments:** OF not visible. Observations done from DI. Standing water but no flow.

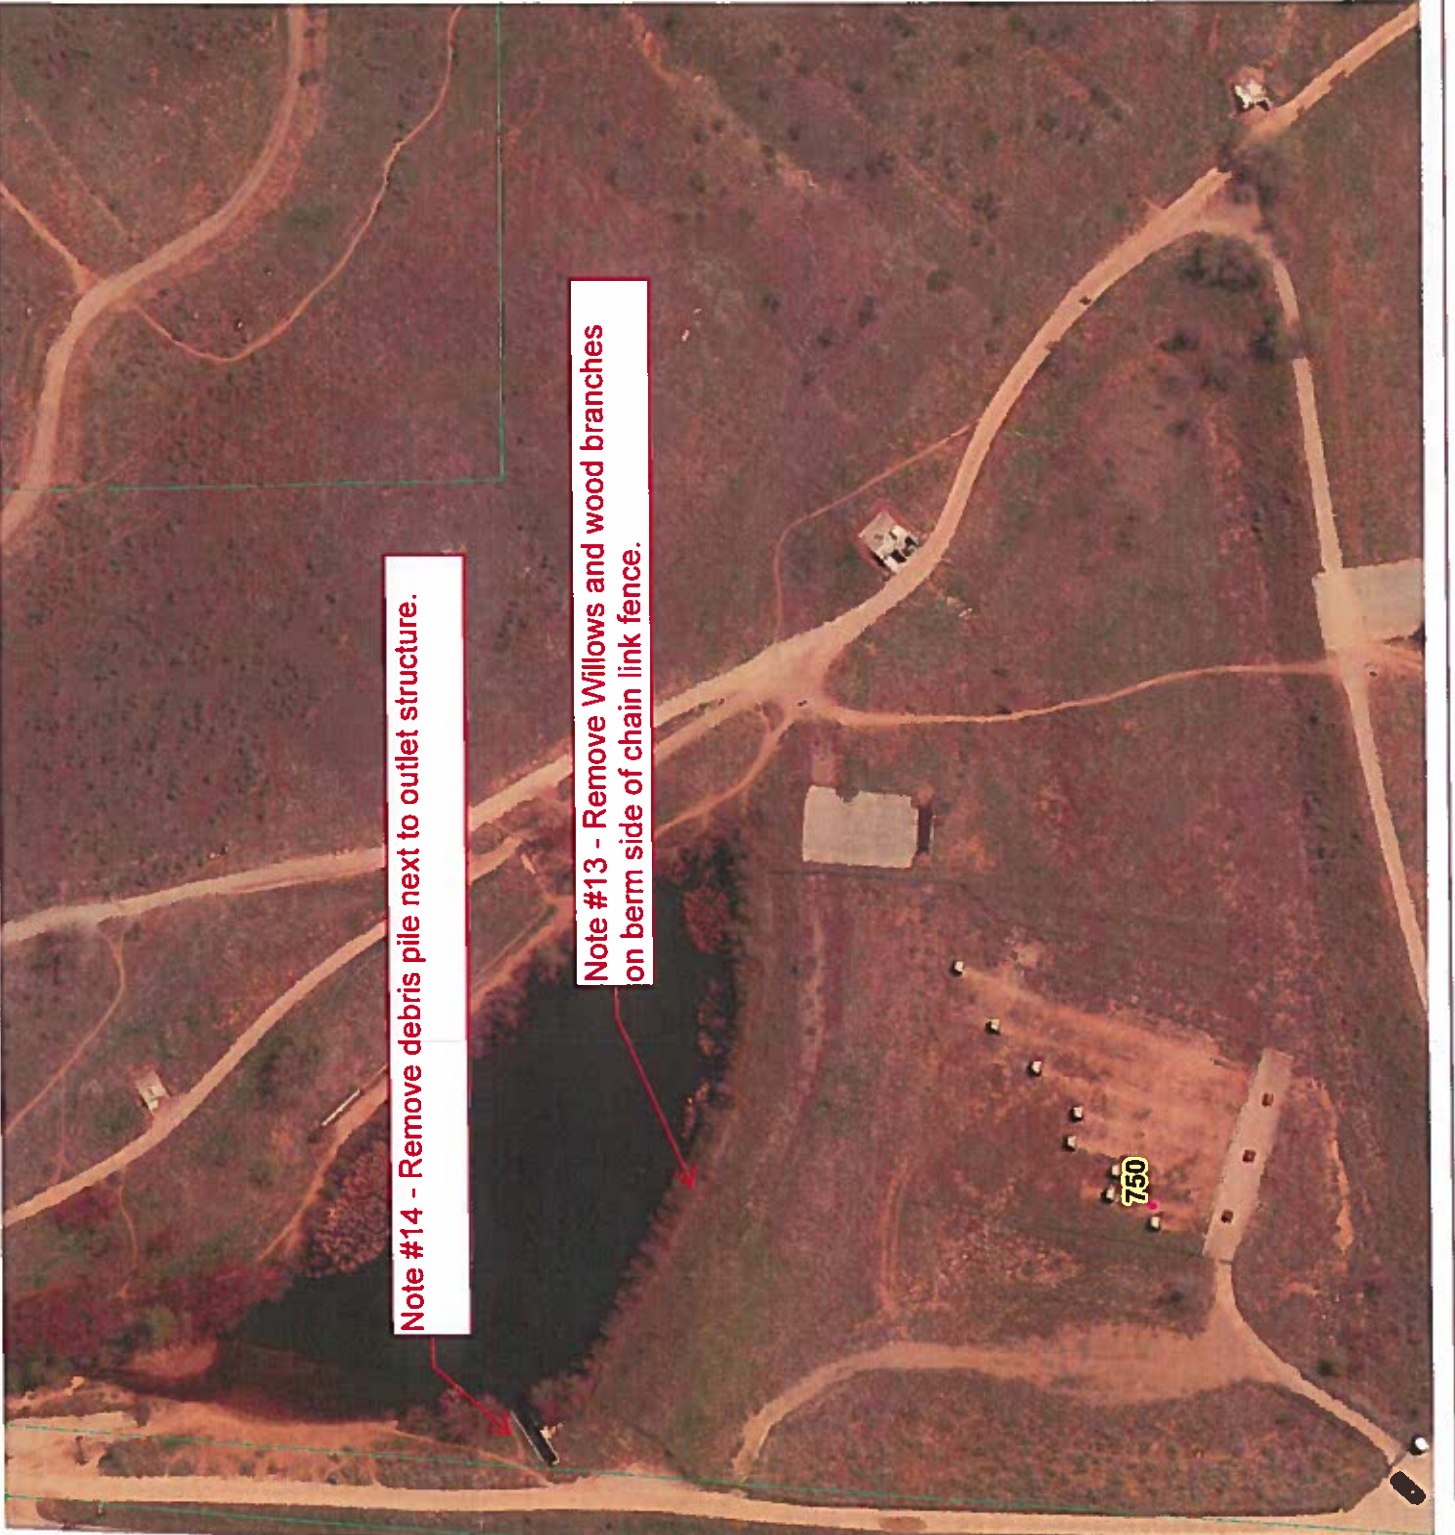
Note #14 - Remove debris pile next to outlet structure.

Note #13 - Remove Willows and wood branches on berm side of chain link fence.

12. Trim willows adjacent to west wall of overflow channel below the 24 inch pipe outlet. Leave the willow roots in place.
13. Trim tree and willow branches overhanging the fence along the south side of Pond 1.

14. Remove debris pile next to outlet structure.
15. PW Utility Maintenance -The box containing the flood wall closure boards (Behind Parks Office Building) needs to be maintained. The lid will not open. Inspect boards for competence and warping. Replace unusable boards.

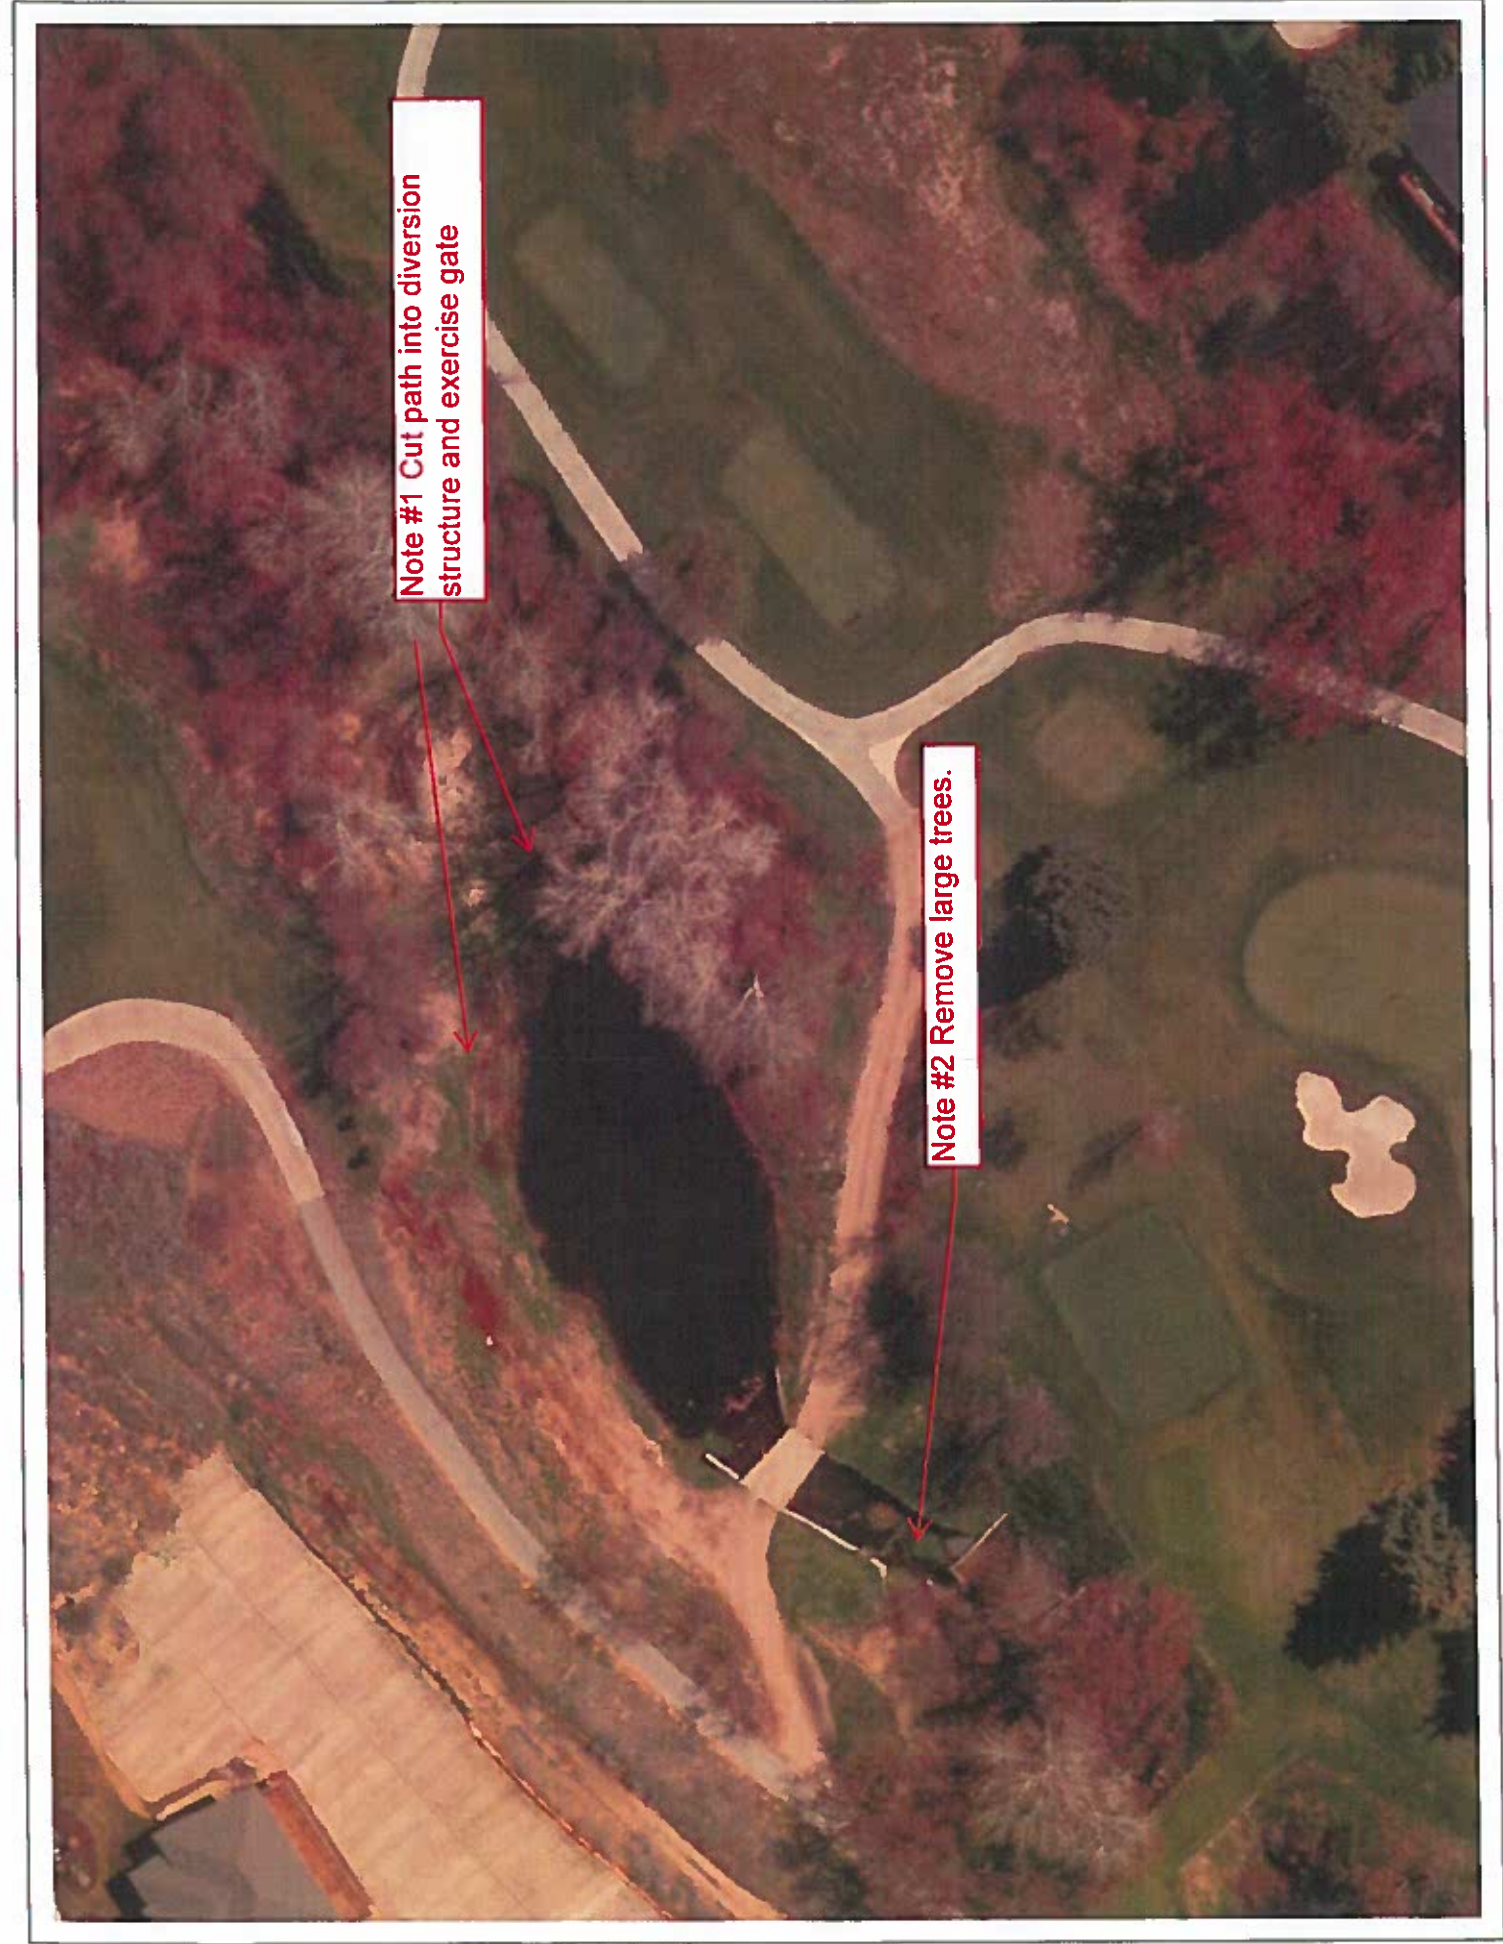
Note #1 Cut path into diversion structure and exercise gate

Note #2 Remove large trees.

1. CALL Tom at Crane Creek Golf Course prior to work for scheduled time (860-883-8589) Cut pathway to access outlet structure. Remove tree debris from outlet flow area when completed.
2. Remove trees/shrubs within 10-15' of outlet opening.

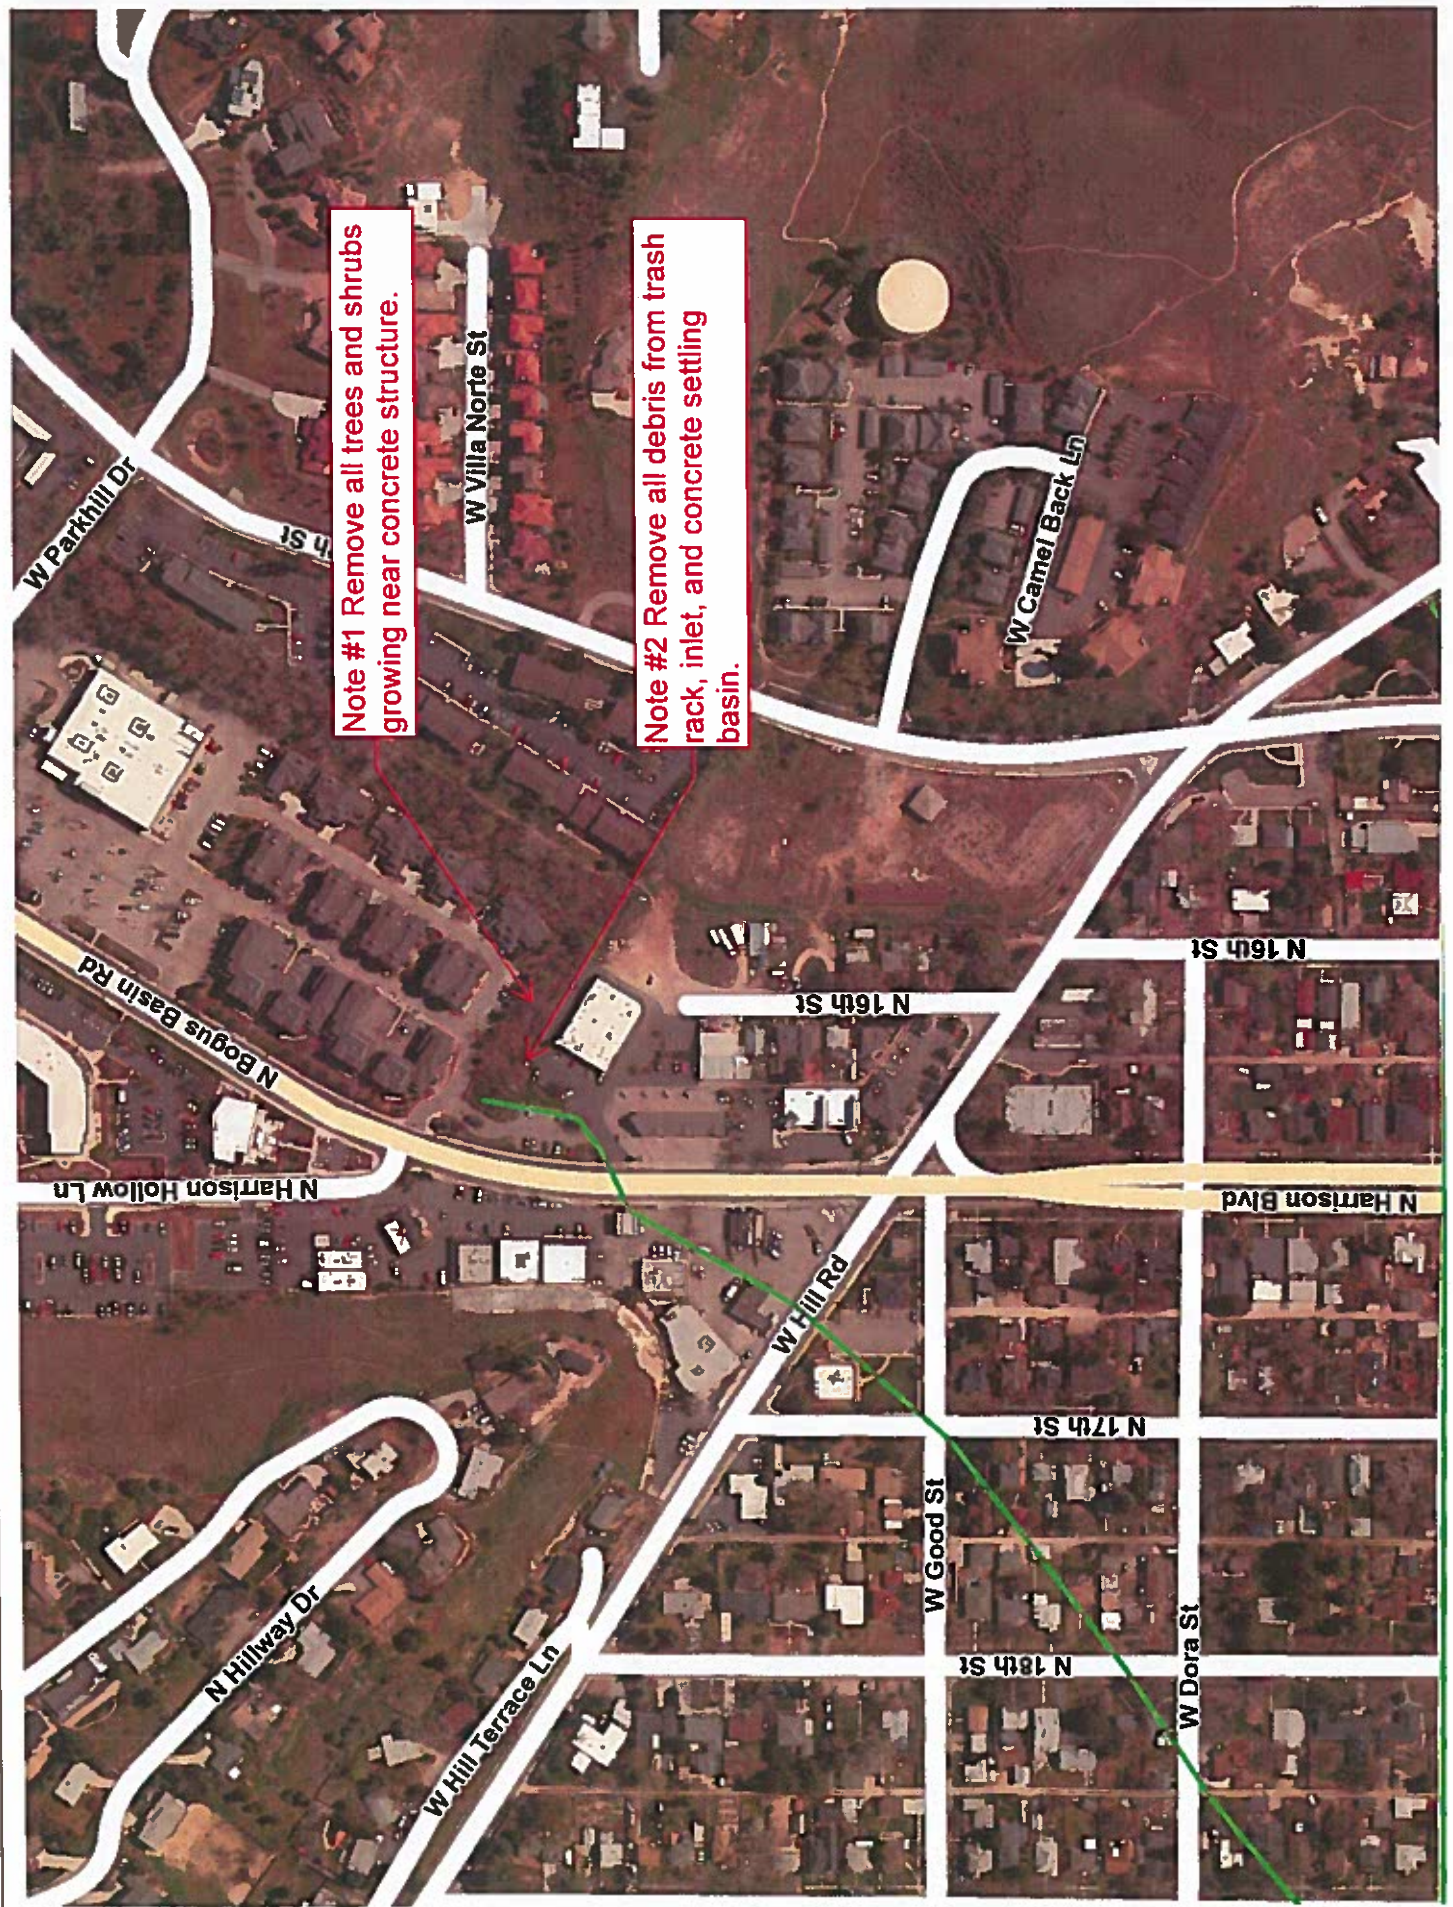
Note #1 Remove all trees and shrubs growing near concrete structure.

Note #2 Remove all debris from trash rack, inlet, and concrete settling basin.

1. Remove all trees and shrubs growing near concrete structure.
2. Remove all debris from trash rack, inlet, and concrete settling basin.

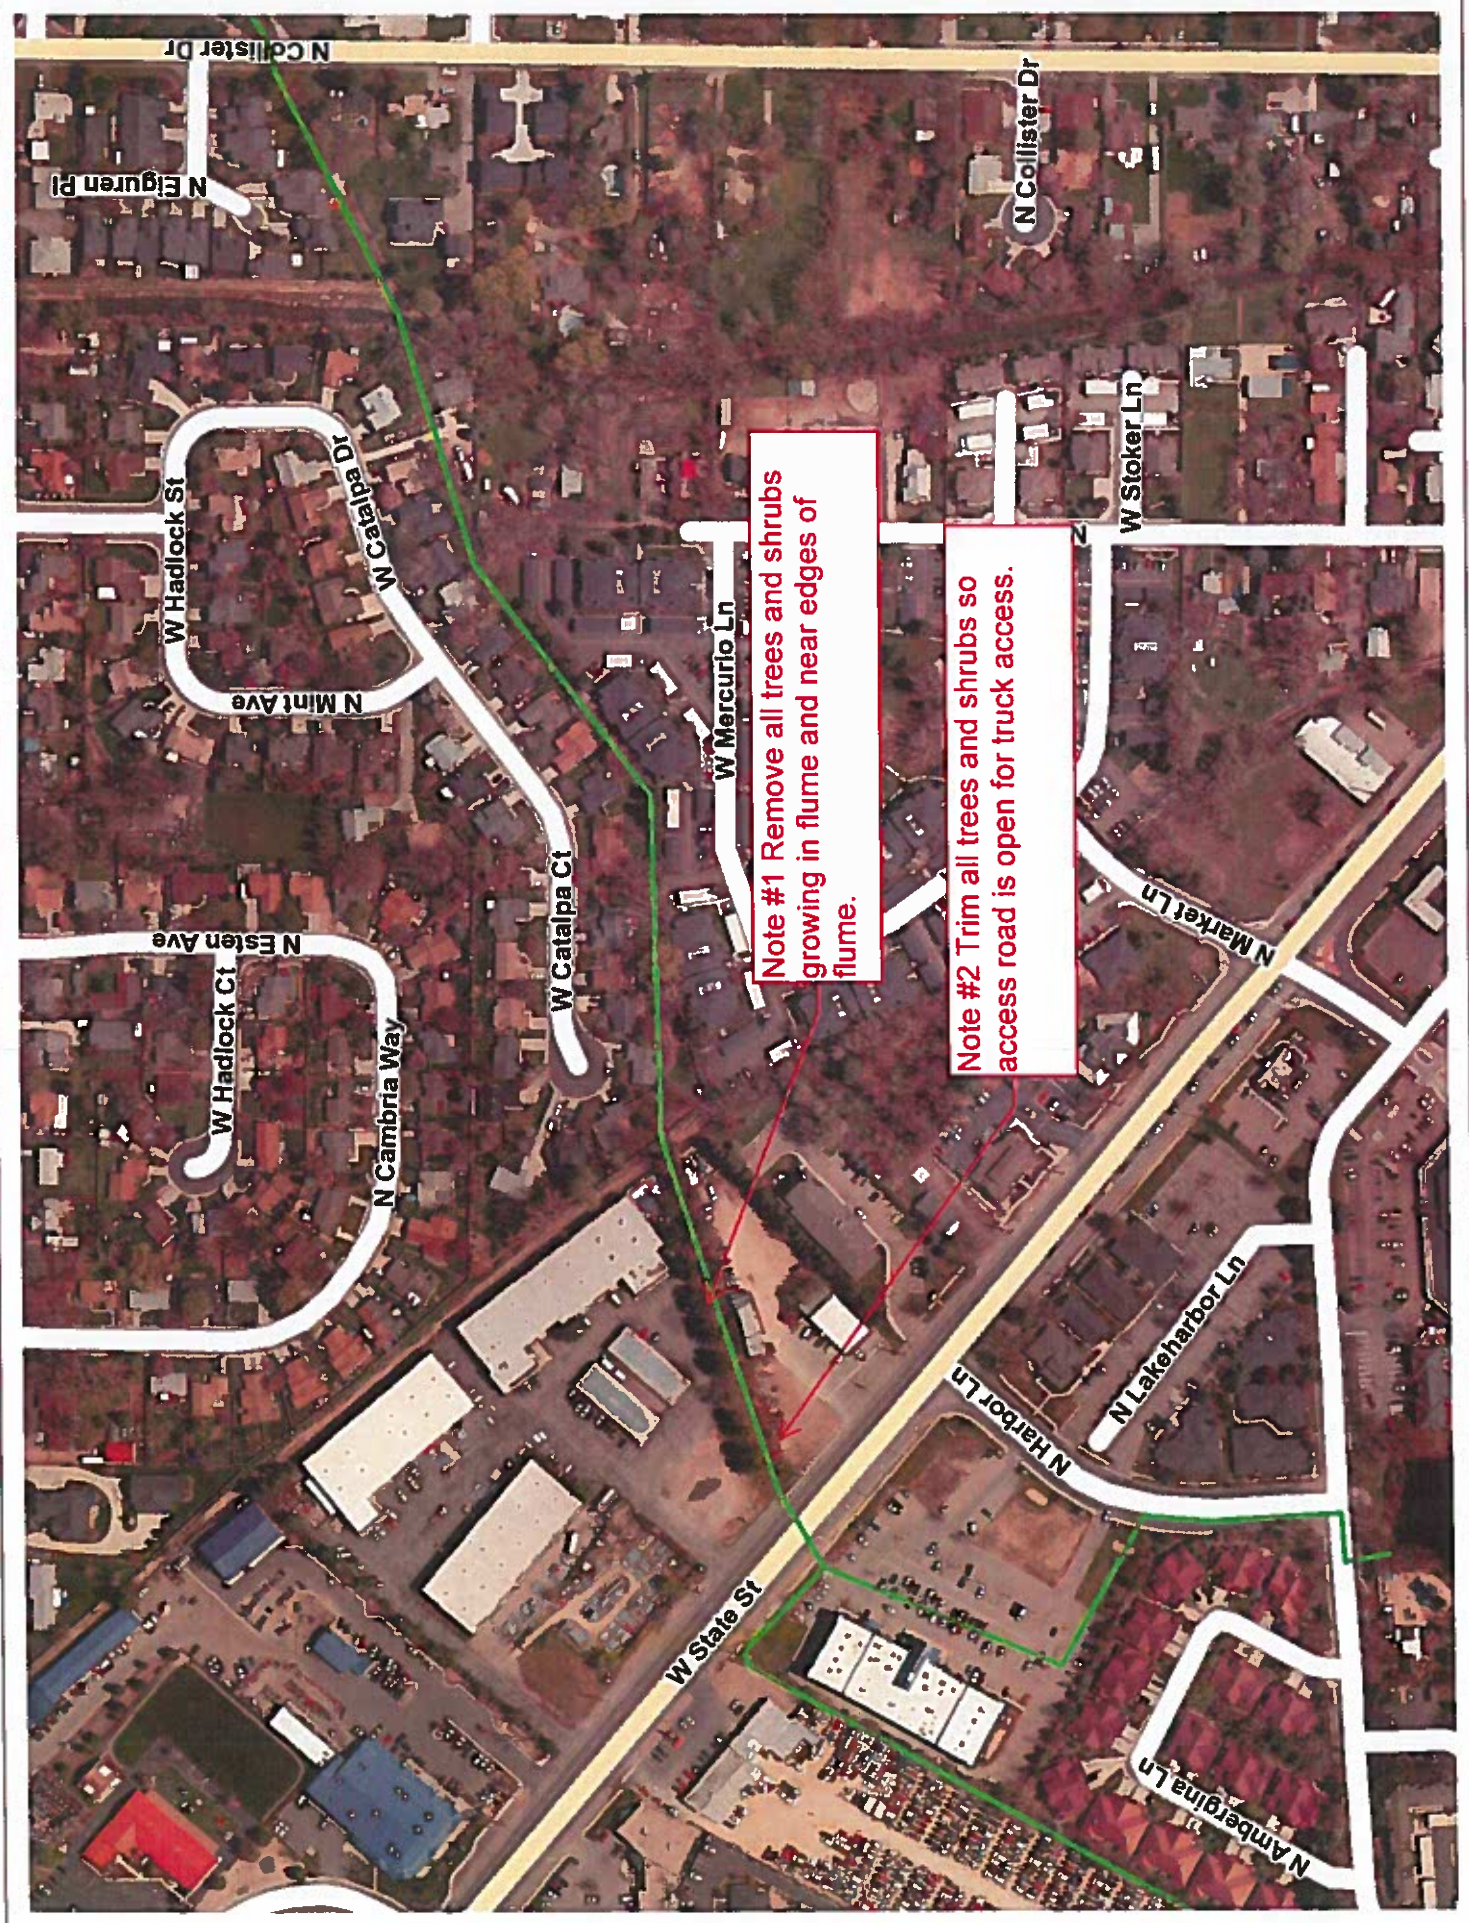
Note #1 Remove all trees and shrubs growing in flume and near edges of flume.

Note #2 Trim all trees and shrubs so access road is open for truck access.

1. Remove all trees and shrubs growing in flume and near edges of flume.
2. Trim all trees and shrubs so access road is open for truck access.

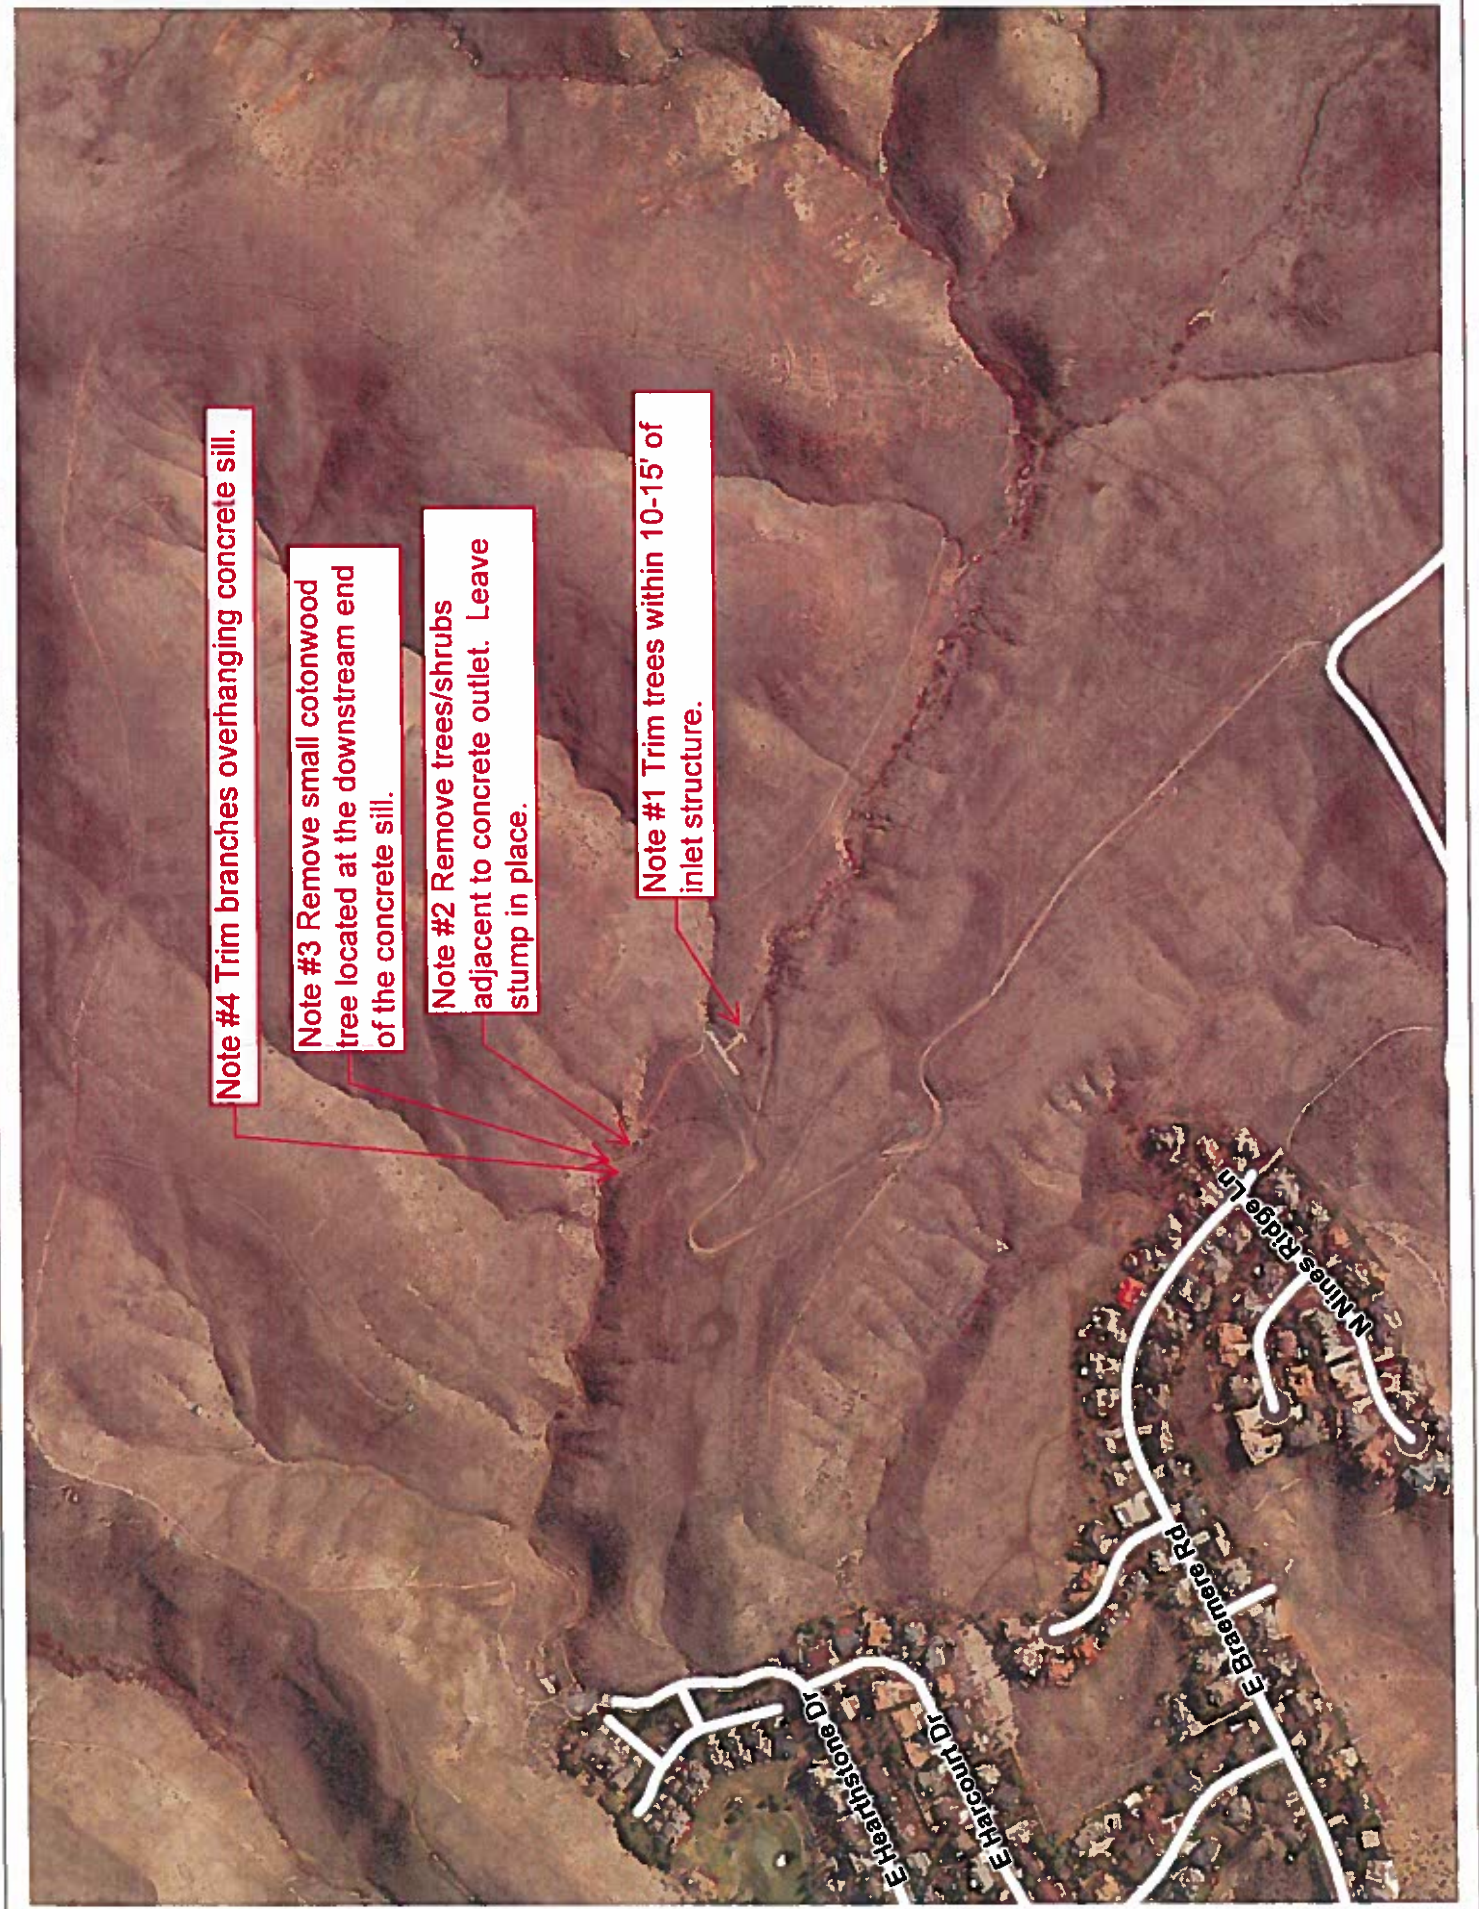
Note #2 Remove trees/shrubs adjacent to concrete outlet. Leave stump in place.

Note #1 Trim trees within 10-15' of inlet structure.
