**MUNICIPAL SEPARATE STORM SEWER SYSTEM (MS4) PERMIT  
PROGRAM**

**2018 ANNUAL REPORT**

**DEPARTMENT OF PUBLIC WORKS  
DECEMBER 21, 2018**

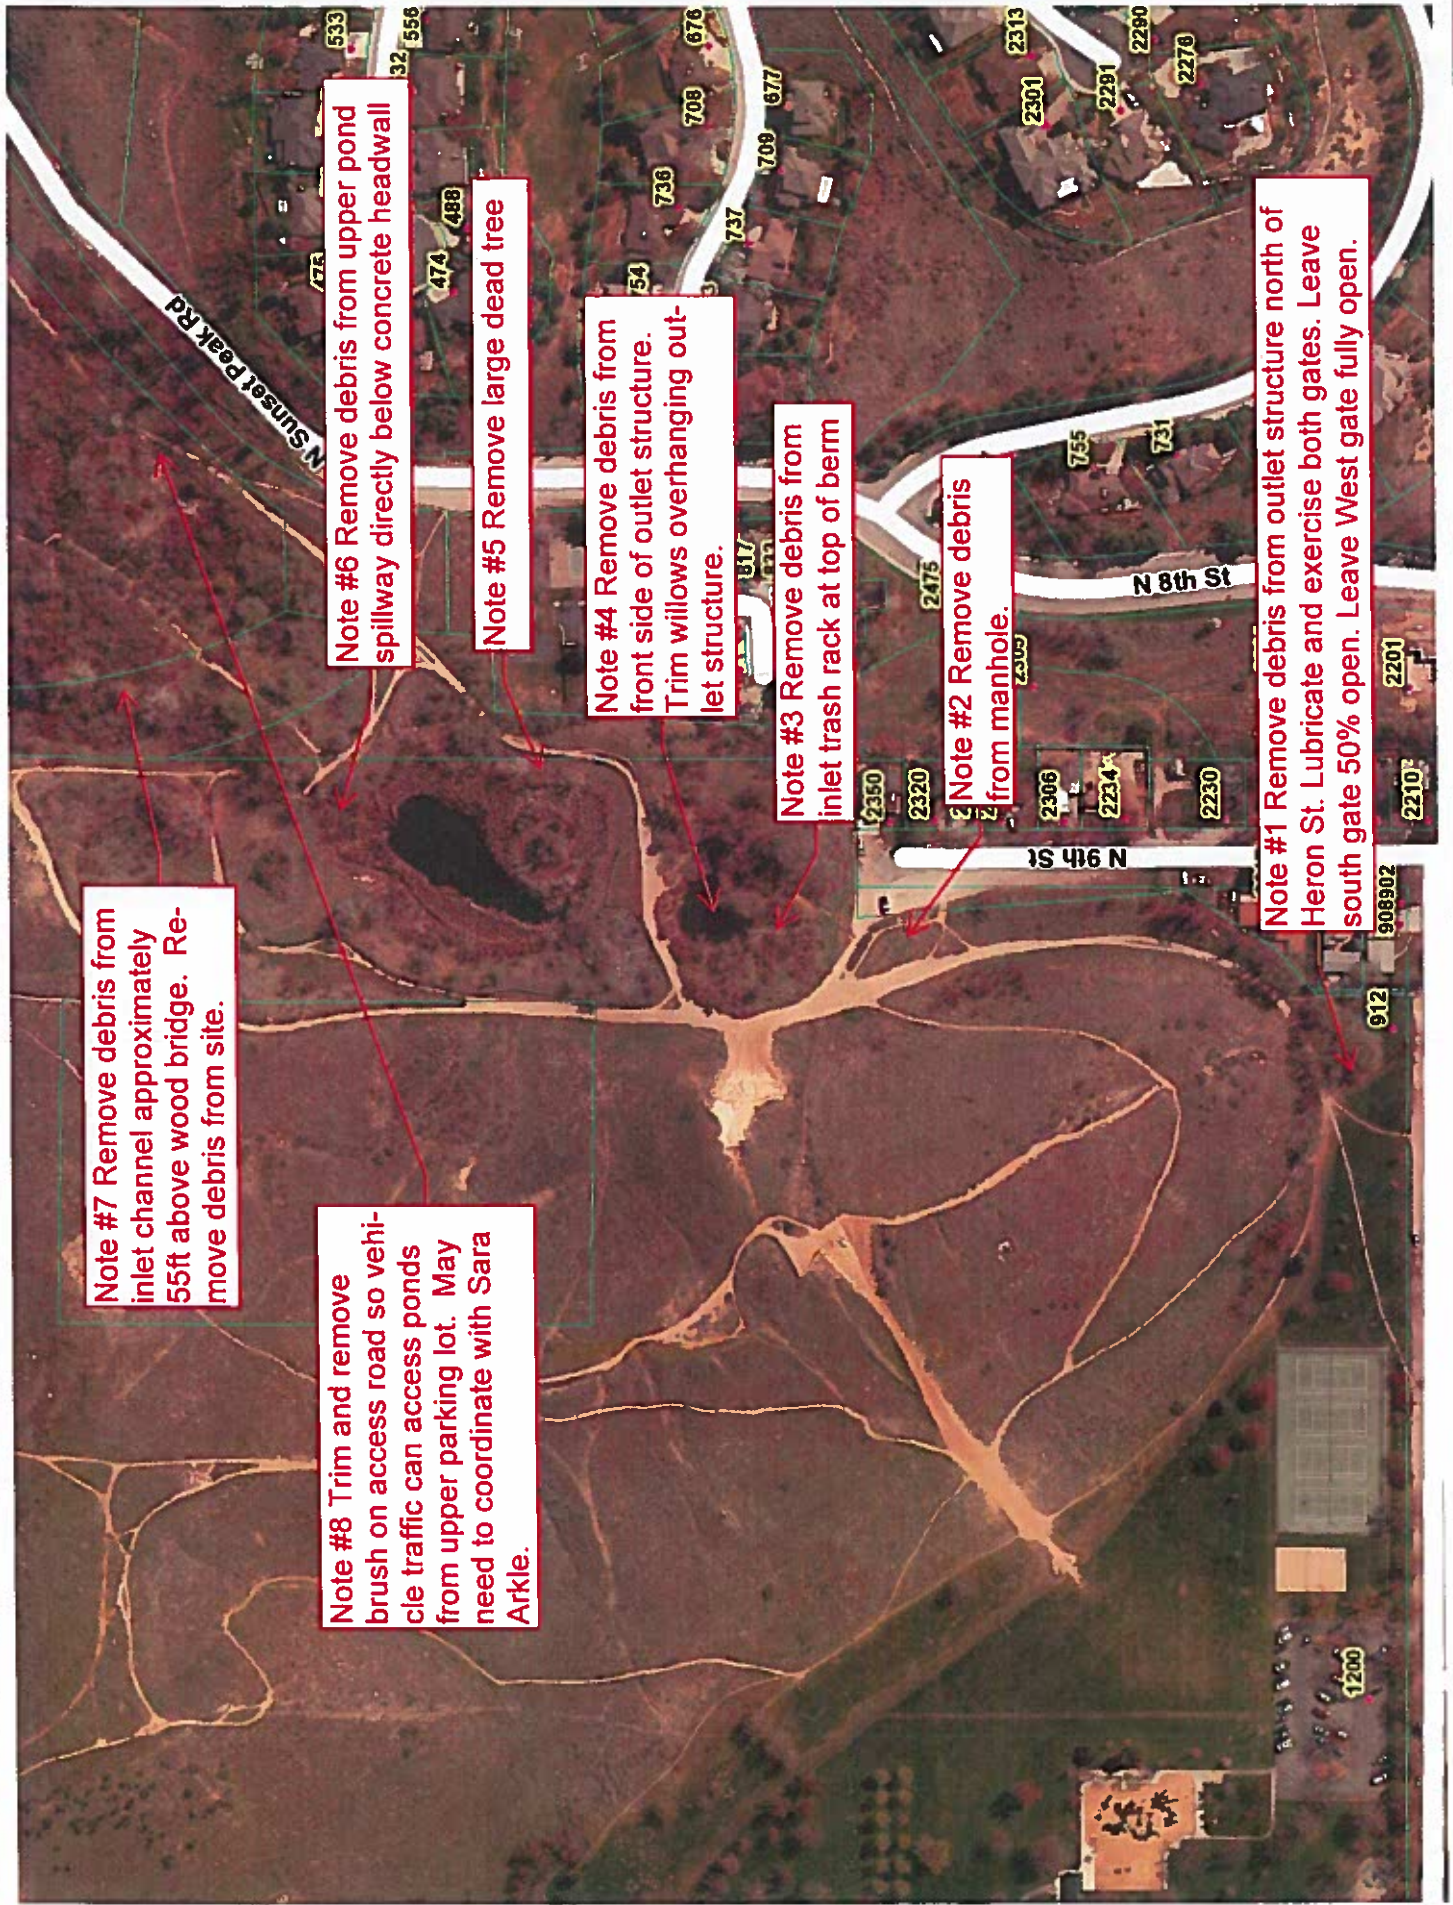
Note #2 Remove debris from manhole.

Note #1 Remove debris from outlet structure north of Heron St. Lubricate and exercise both gates. Leave south gate 50% open. Leave West gate fully open.

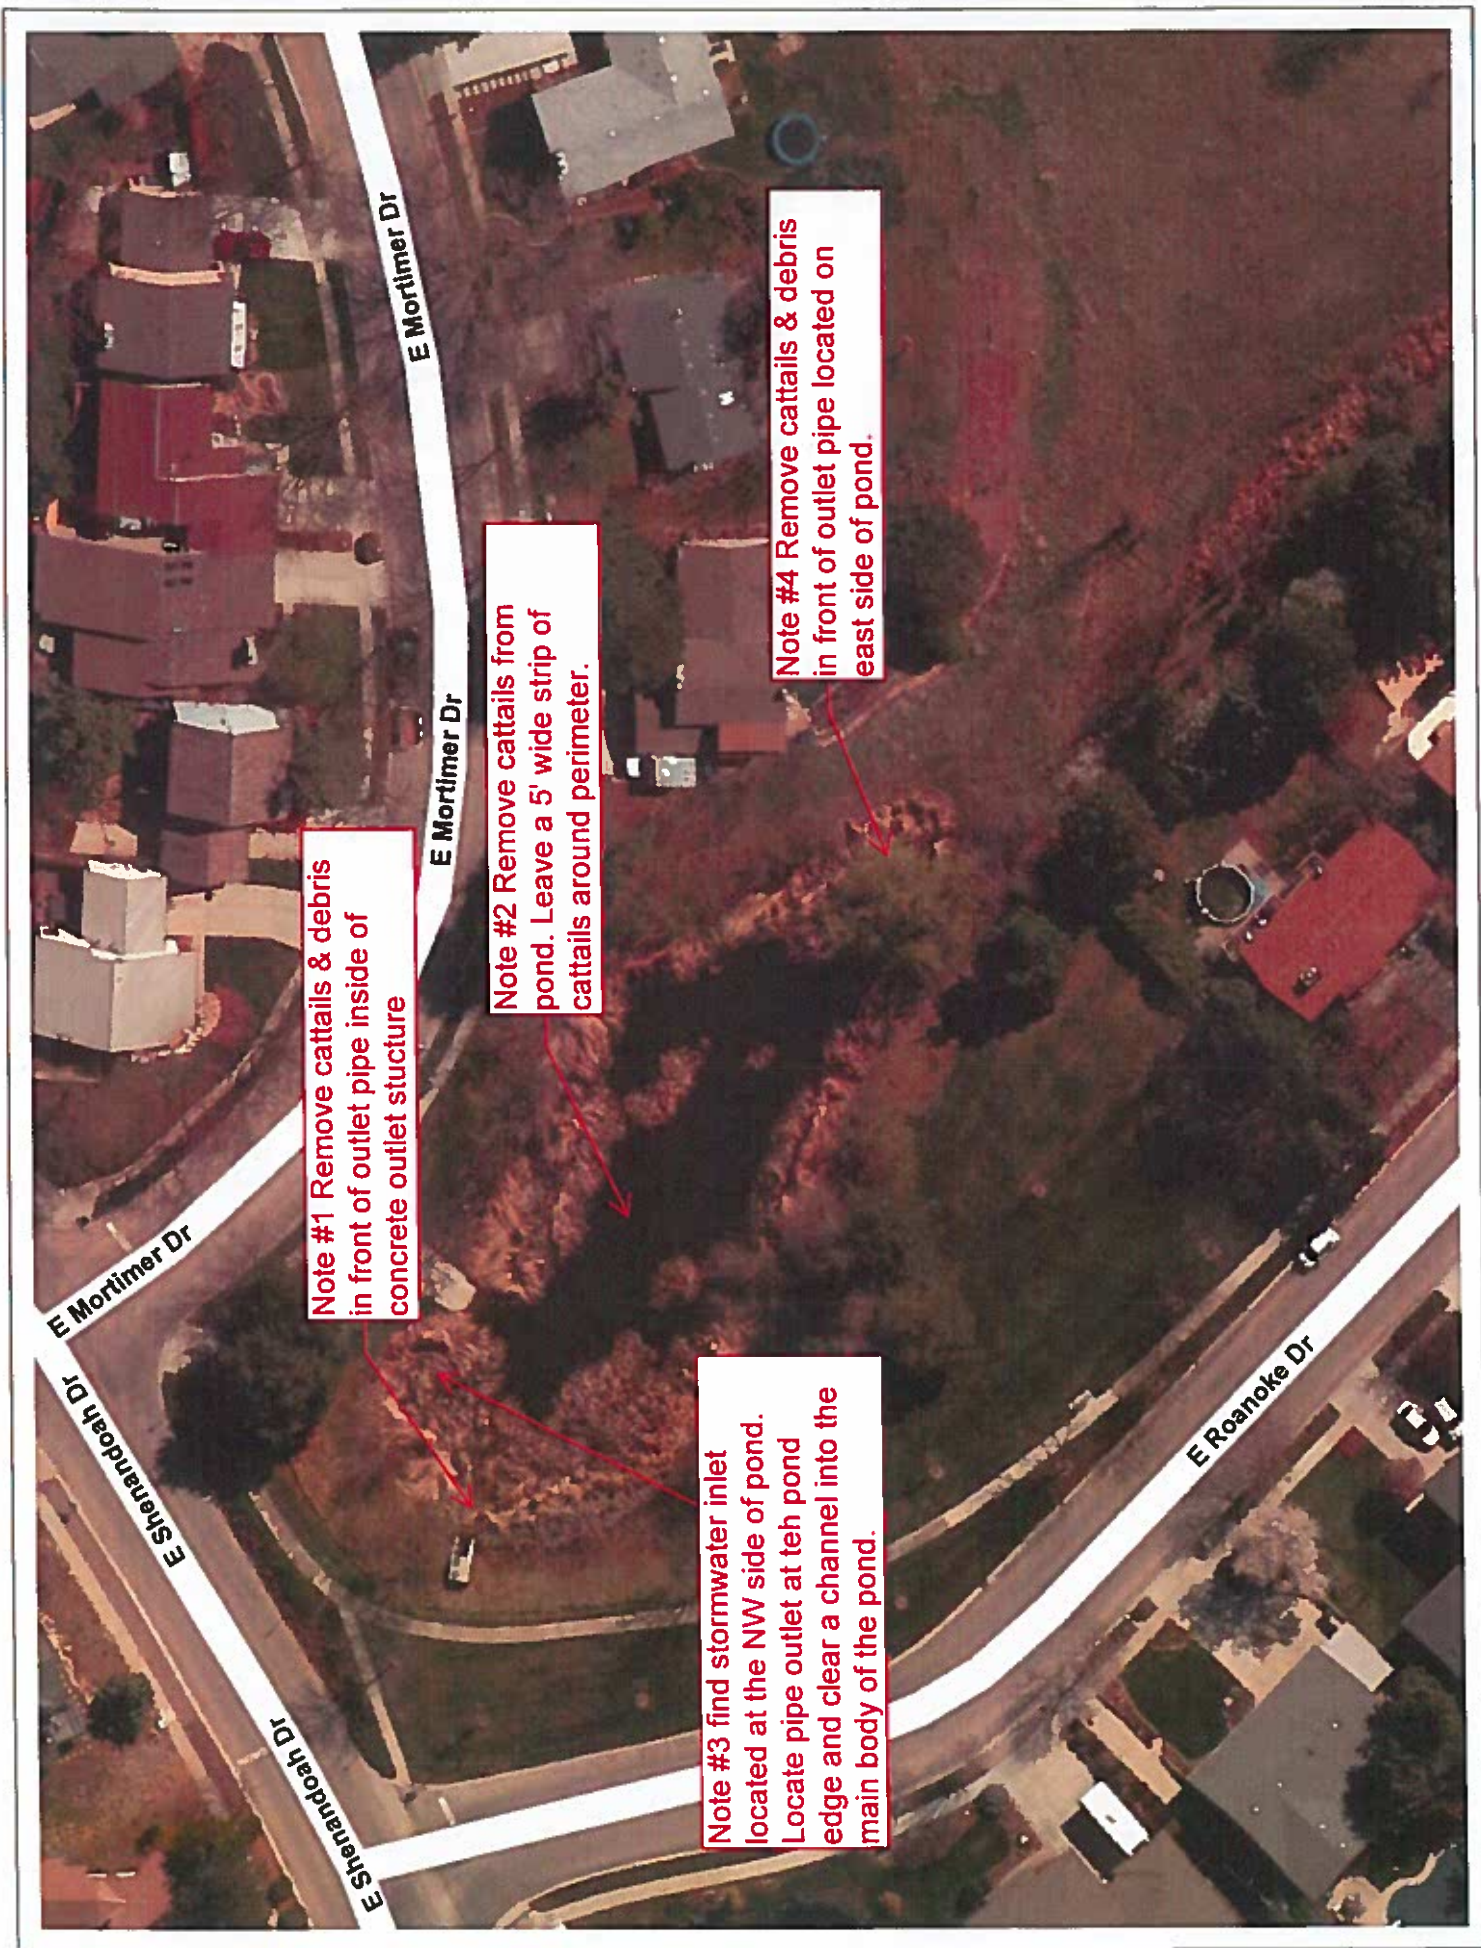
Note #1 Remove cattails & debris in front of outlet pipe inside of concrete outlet structure

Note #2 Remove cattails from pond. Leave a 5' wide strip of cattails around perimeter.

1. Remove debris and cattails in front of outlet structure.
2. Cattails have encroached all the way to the concrete pond bottom. Remove cattails. Leave a perimeter strip of cattails approximately five to ten feet wide along all pond edges.
3. There is a stormwater inlet located at the northwest side of the pond. Locate the pipe outlet at the pond edge and clear a channel into the main body of the pond.
4. Remove cattails and debris below the inlet pipe located at the east side of the pond.

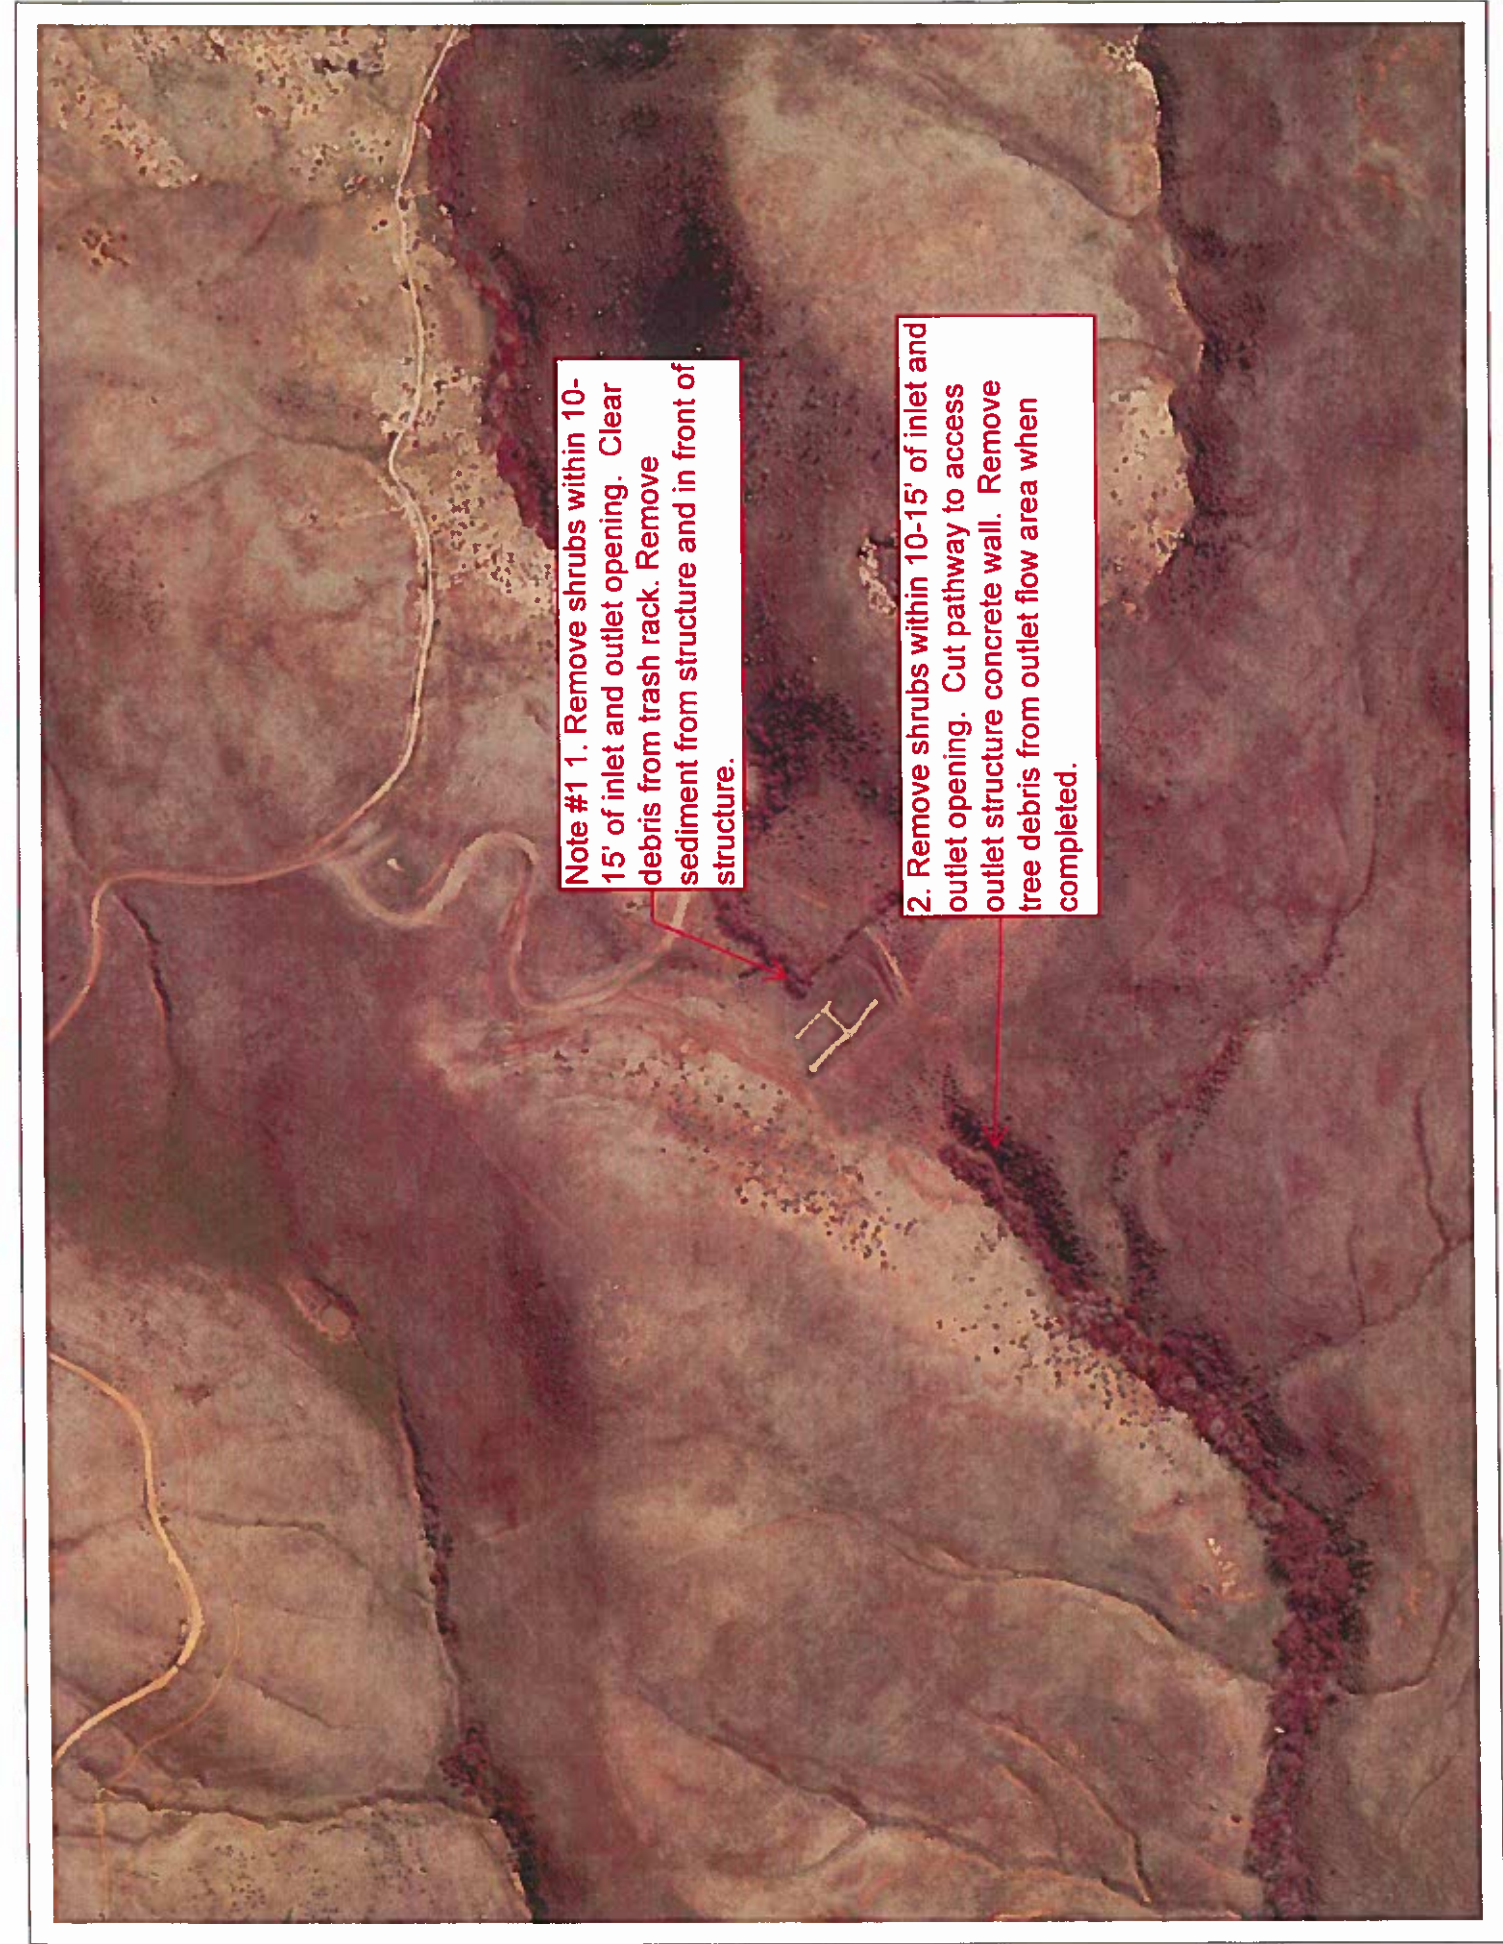
An aerial photograph of a river with two callout boxes. The first box, labeled 'Note #1', points to a section of the riverbank with a yellow 'H' marking. The second box points to a section of the riverbank further downstream. The river is brown and turbulent, with visible debris and sediment. The surrounding land is a mix of brown and green, with some rocky areas.

Note #1 1. Remove shrubs within 10-15' of inlet and outlet rack. Clear debris from trash rack. Remove sediment from structure and in front of structure.

1. Remove shrubs within 10-15' of inlet and outlet opening. Clear debris from inlet trash rack.
2. Remove shrubs within 10-15' of inlet and outlet opening. Cut pathway across concrete sill.  
Remove shrub debris from outlet flow area when completed.

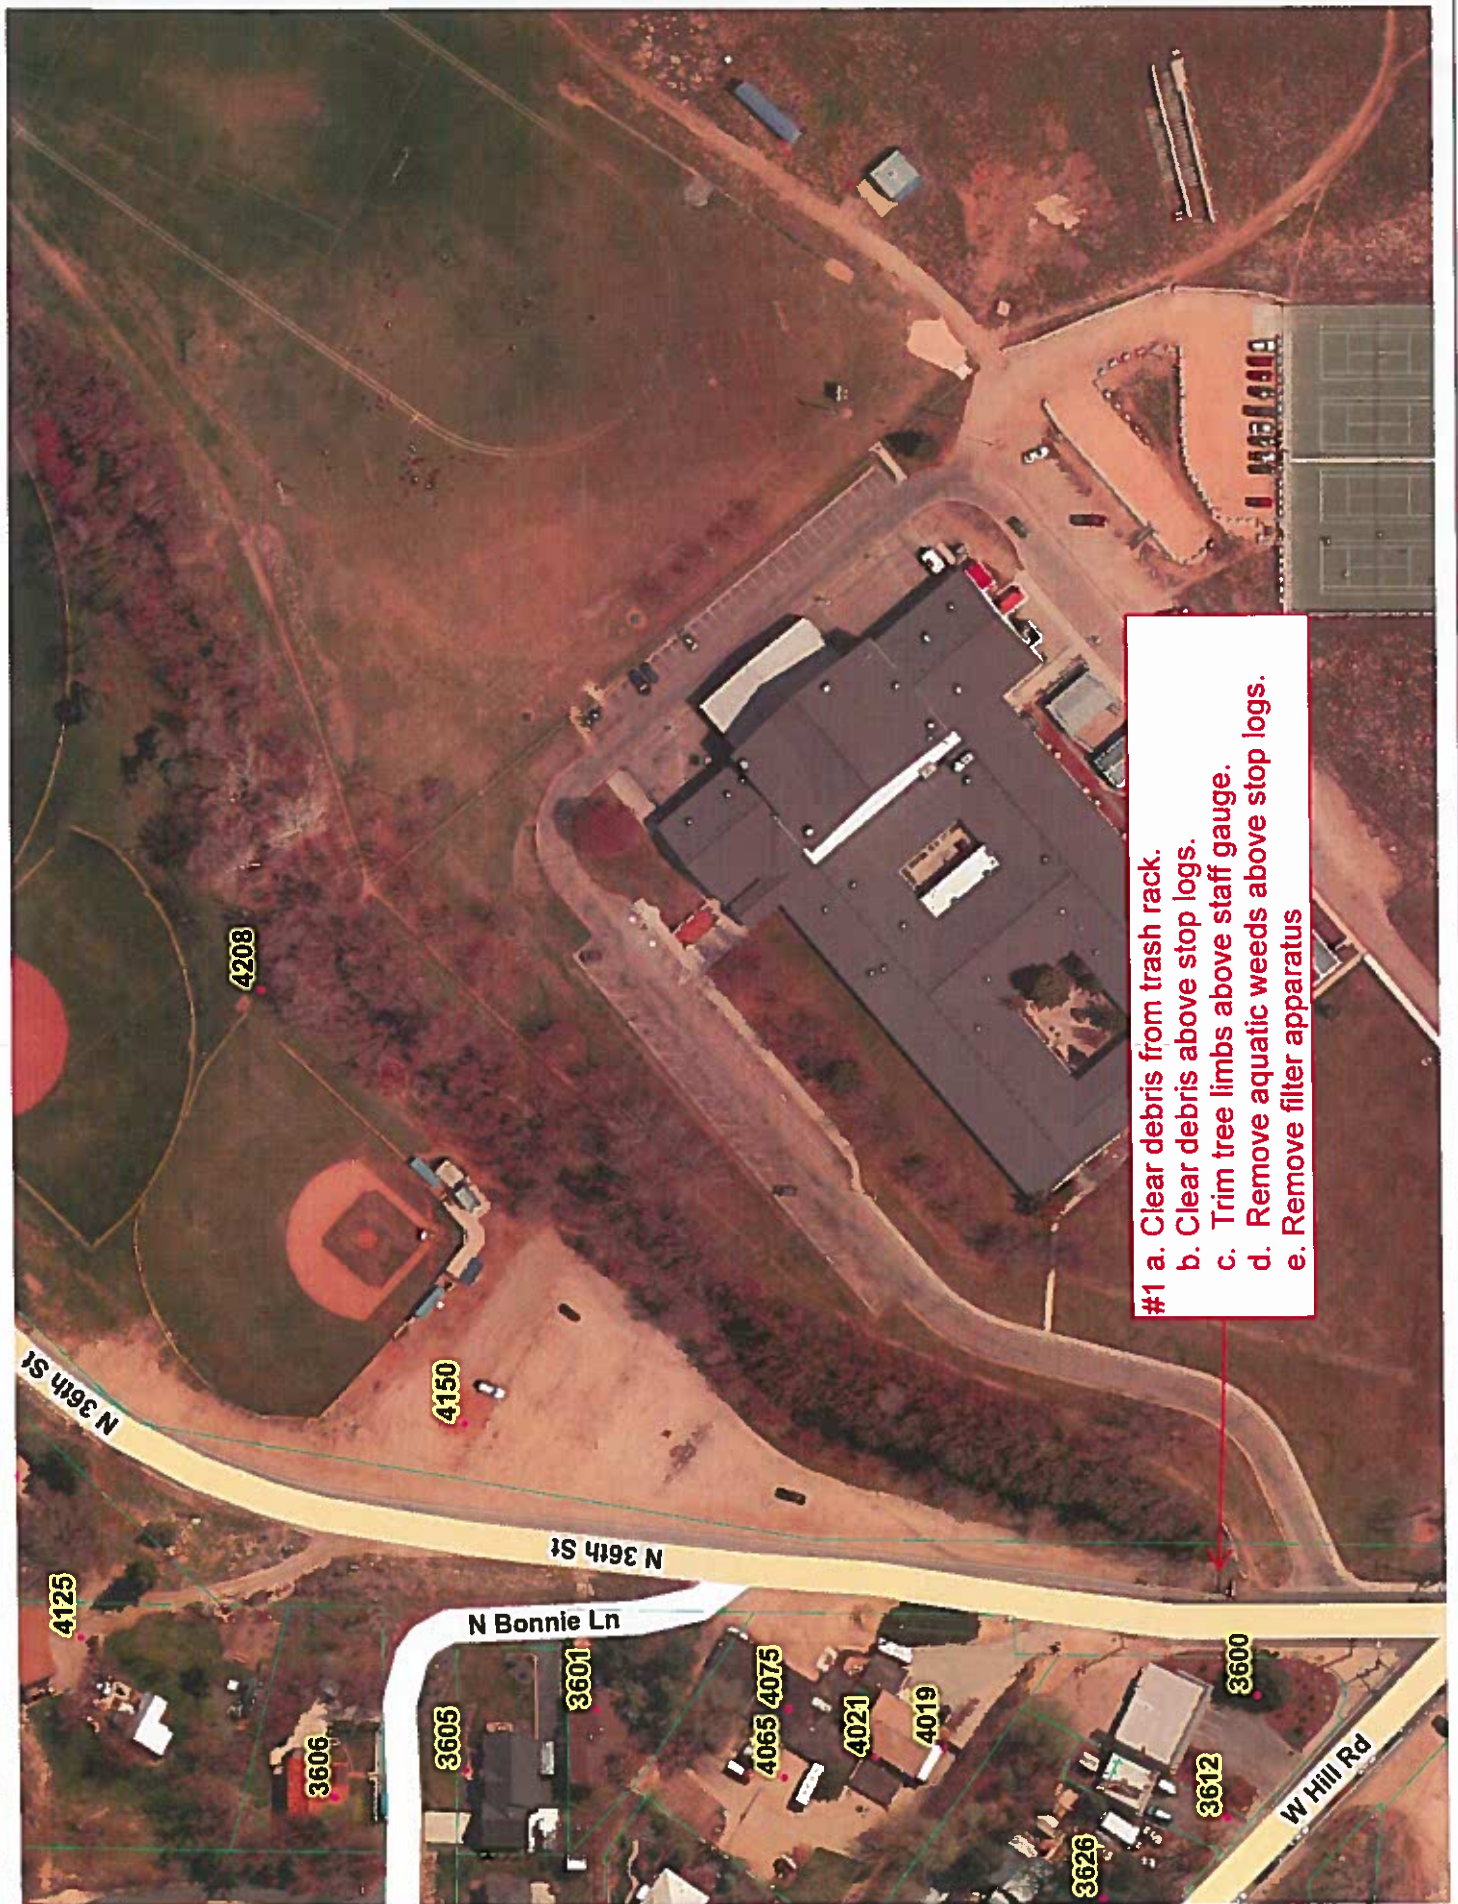
- #1
- a. Clear debris from trash rack.
  - b. Clear debris above stop logs.
  - c. Trim tree limbs above staff gauge.
  - d. Remove aquatic weeds above stop logs.
  - e. Remove filter apparatus

- a. Clear debris from trash rack.
- b. Clear debris above stop logs.
- c. Trim tree limbs above staff gauge.
- d. Remove aquatic weeds above stop logs.
- e. Remove filter apparatus.

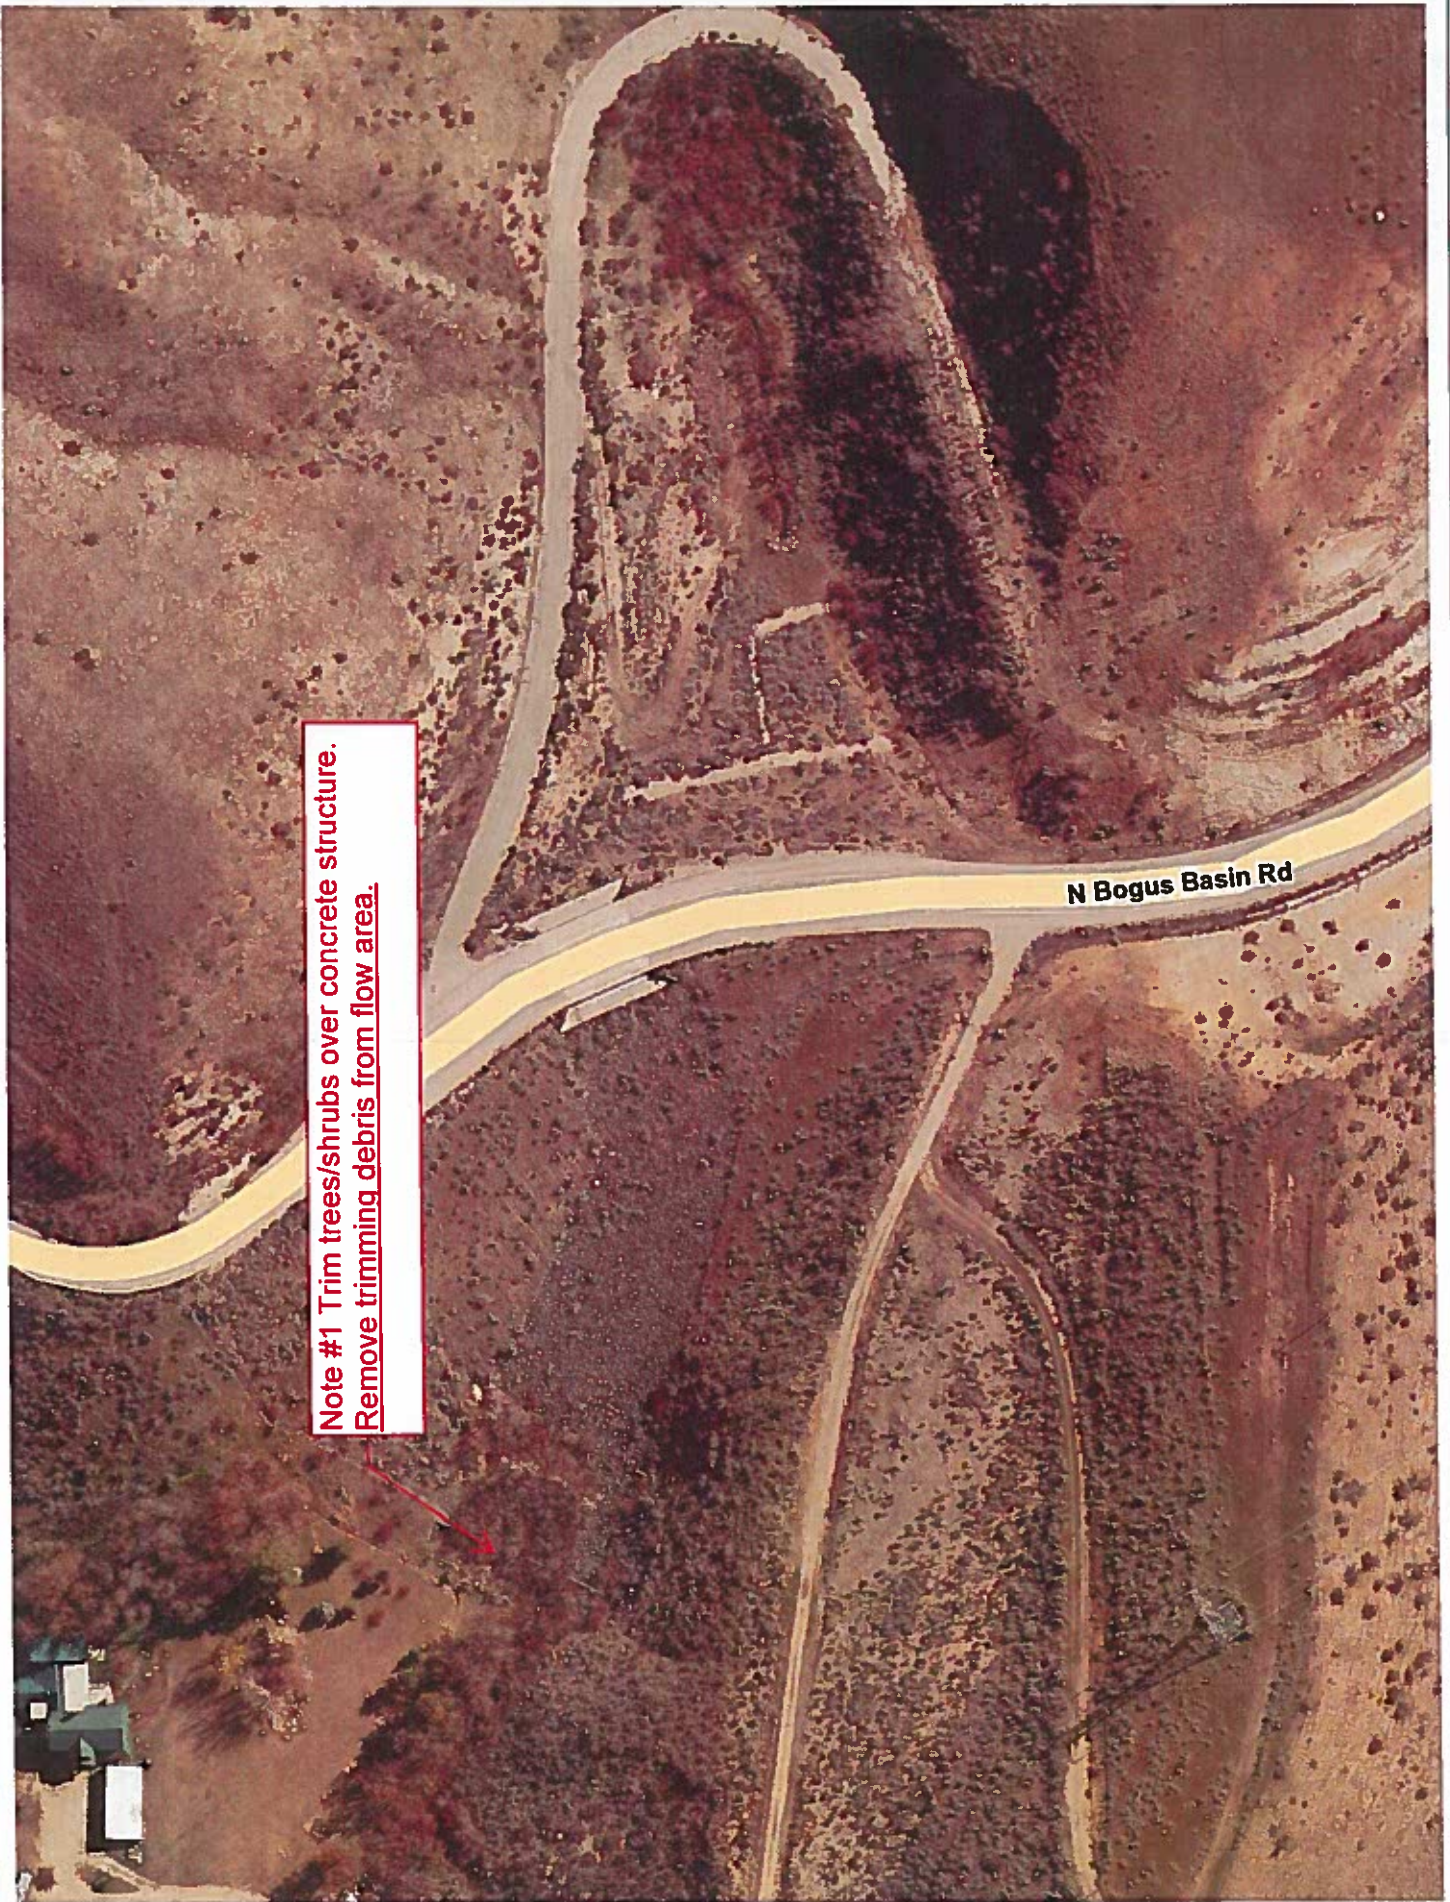
**Note #1 Trim trees/shrubs over concrete structure.  
Remove trimming debris from flow area.**

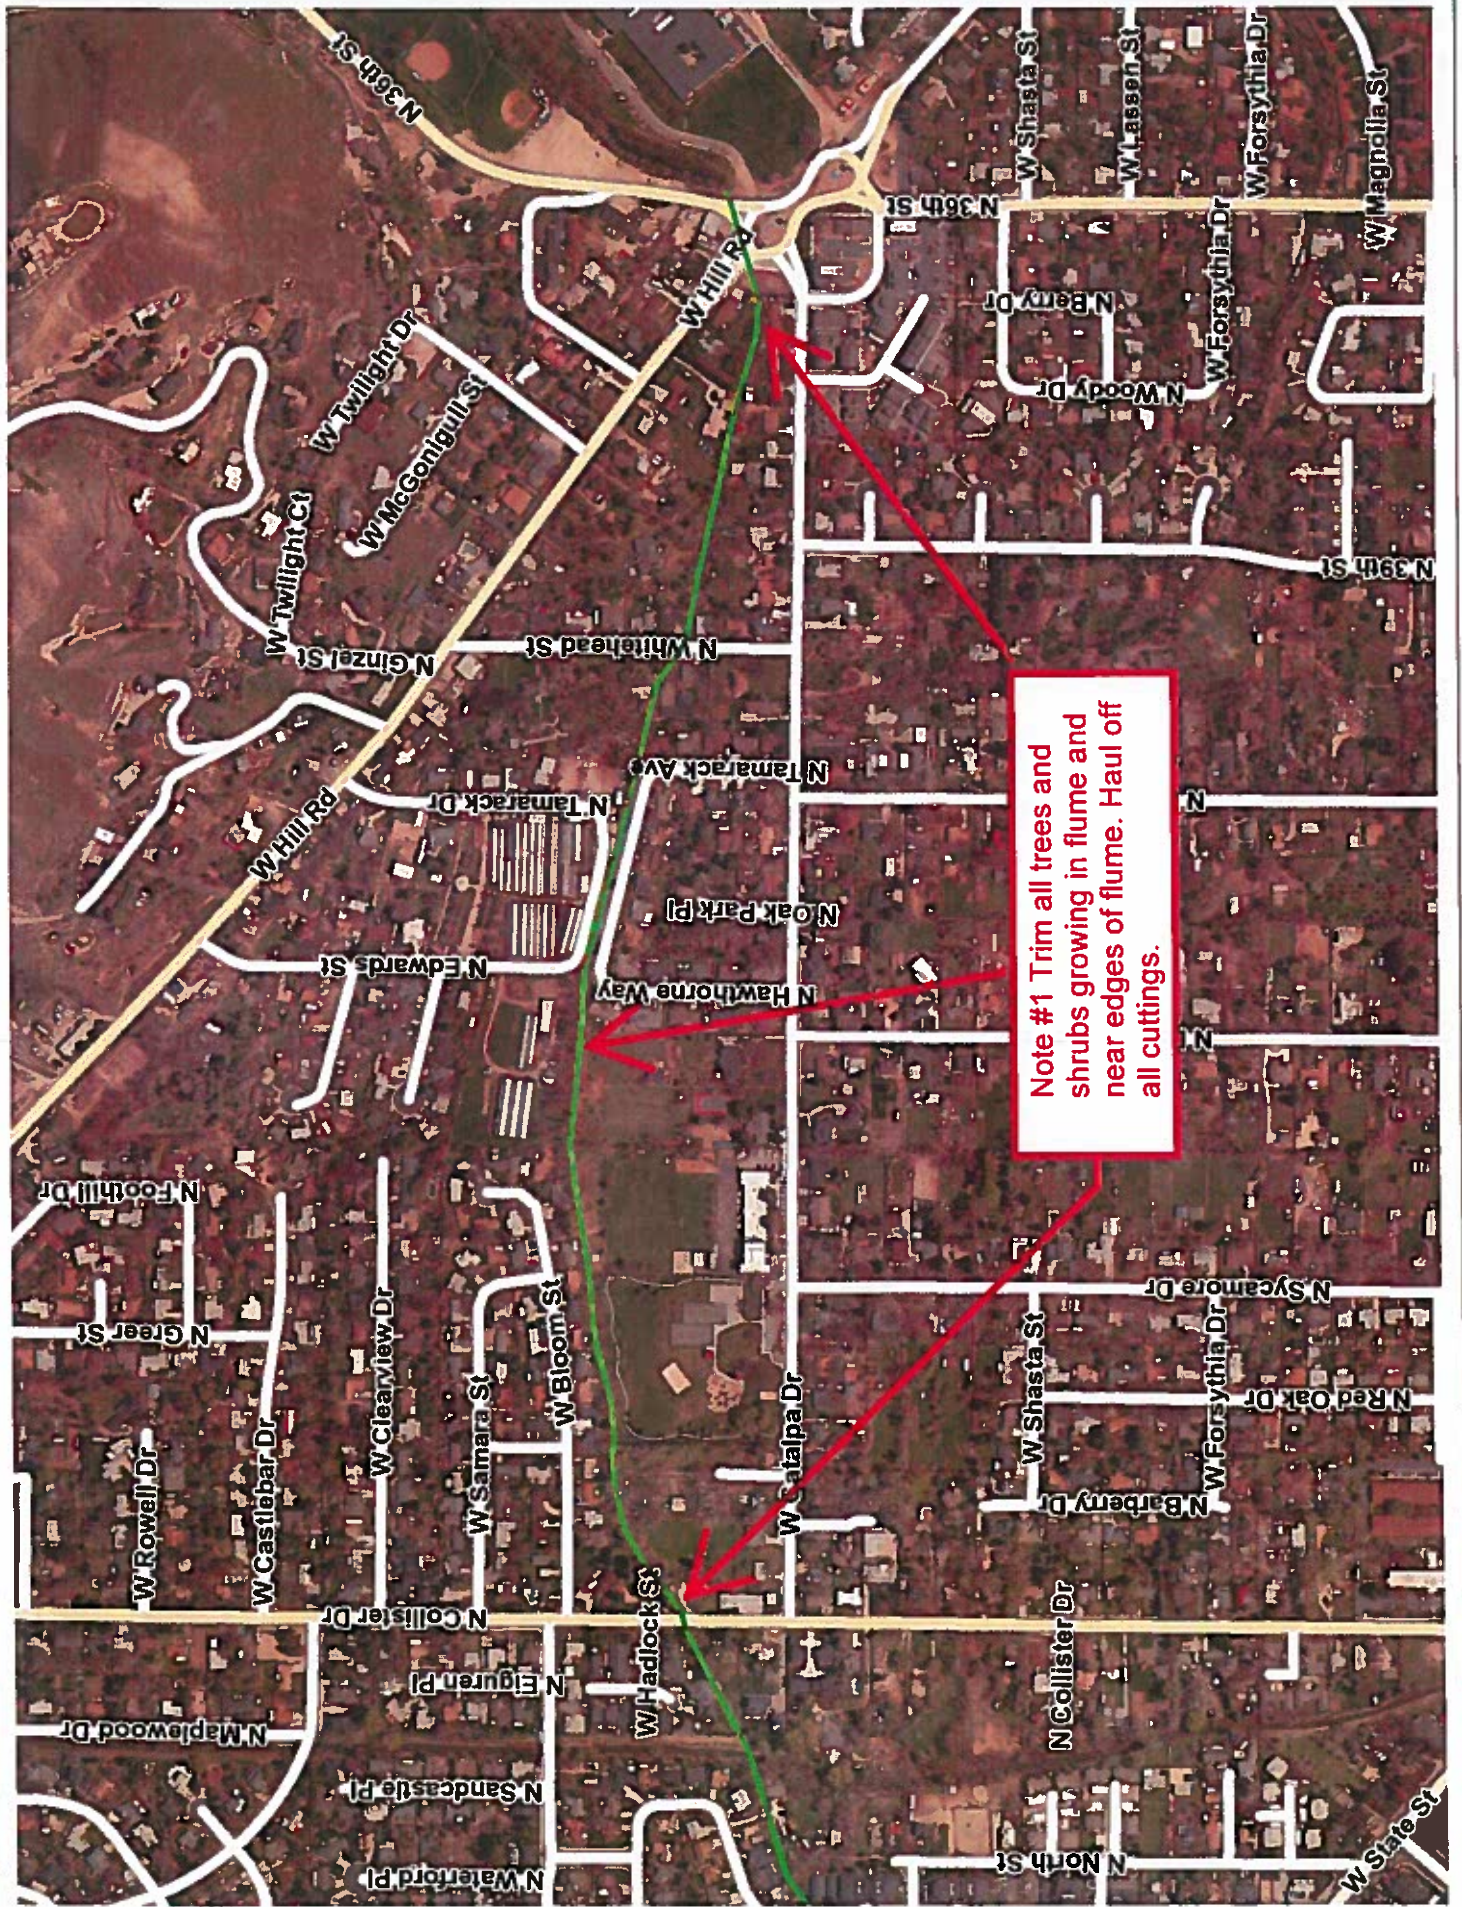
Note #1 Trim all trees and shrubs growing in flume and near edges of flume. Haul off all cuttings.

1. Trim all trees and shrubs growing in flume and near edges of flume. Haul off all cuttings.

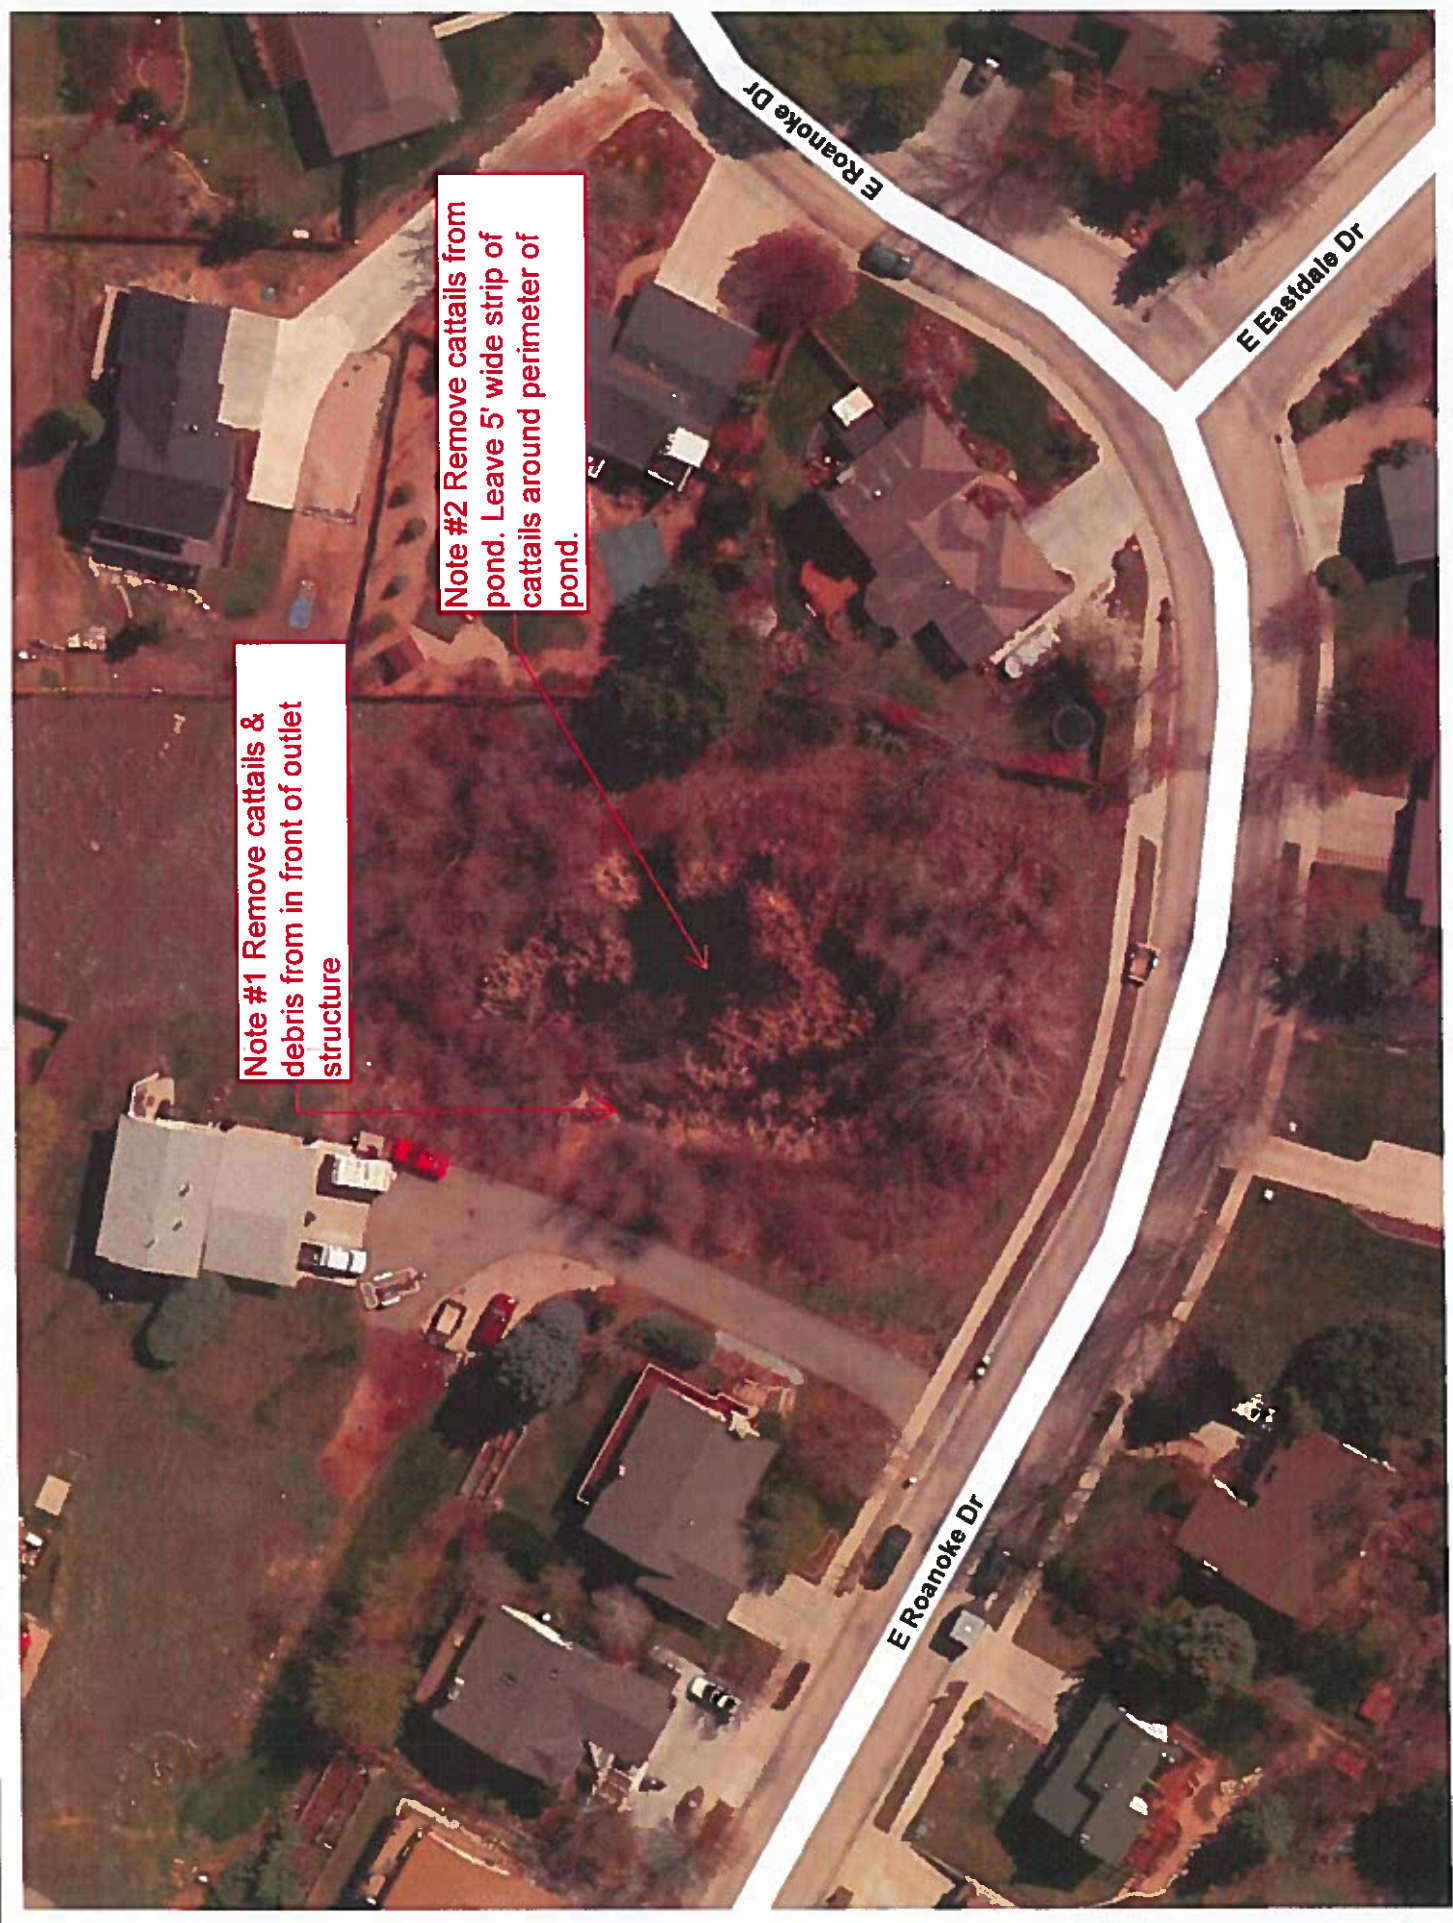
Note #1 Remove cattails & debris from in front of outlet structure

Note #2 Remove cattails from pond. Leave 5' wide strip of cattails around perimeter of pond.

1. Remove cattails and debris in front of outlet structure.
2. Minimal open water in pond. Remove cattails. Leave a minimum five foot wide strip of cattails around the perimeter of the pond.
